Your Ref: TP/IP/65603/2017  
Our Ref : CI/TPD18001967/Z

**Fatal Accident Investigation Team**

**MECHANICAL INSPECTION REPORT OF MOTOR CAR SJR 4331E**

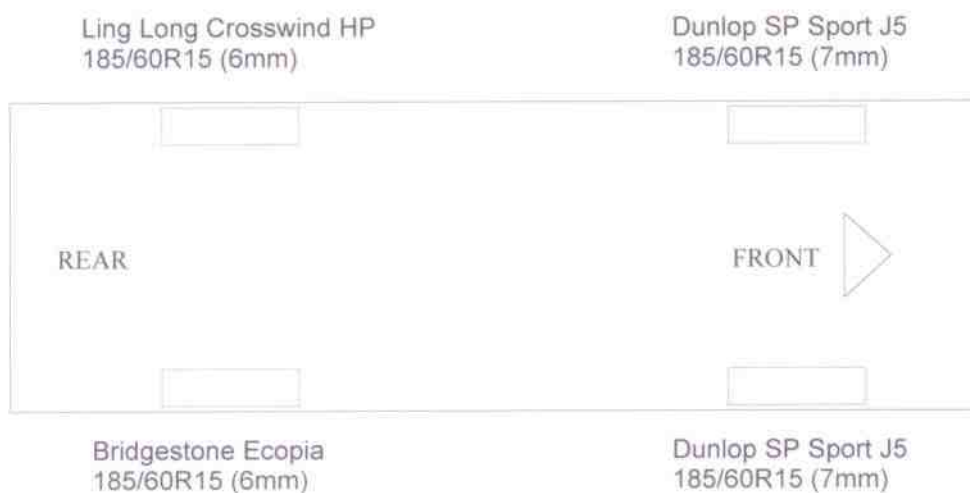
7. The condition of the Motor Car's 4 tyres was observed to be in serviceable condition. We did not find any tear, cut or burst mark(s) on the outer and the inner sidewalls as well as across the tread of the 4 tyres. The 4 tyres were also observed to be sufficiently inflated for vehicular operation. The tyre brand, tyre size and remaining tread depth of the 4 tyres were recorded as follows:-
