Your Ref: TP/IP/62725/2017
Our Ref : CI/TPD18002535/N

25 January 2018

MECHANICAL INSPECTION REPORT OF MOTOR TAXI SH 8506M

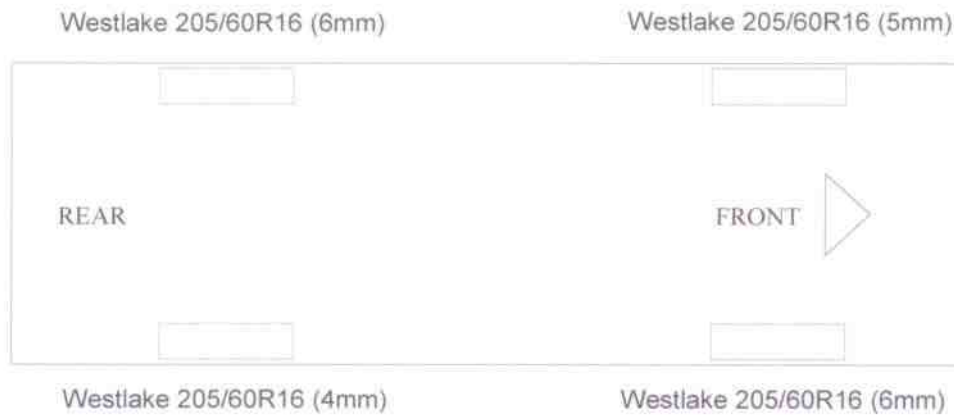
6. The condition of the Motor Taxi's 4 tyres was observed to be in serviceable condition. We did not found any tear, cut or burst mark(s) on the outer and the inner sidewalls as well as across the tread of the 4 tyres. The 4 tyres were also observed to be sufficiently inflated for vehicular operation. The tyre brand, tyre size and remaining tread depth of the 4 tyres were recorded as follows:-
