Your Ref: TP/IP/64871/2017  
Our Ref : CI/TPD18002601/N

**Fatal Accident Investigation Team**

**MECHANICAL INSPECTION REPORT OF MOTOR LORRY YP 6093L**

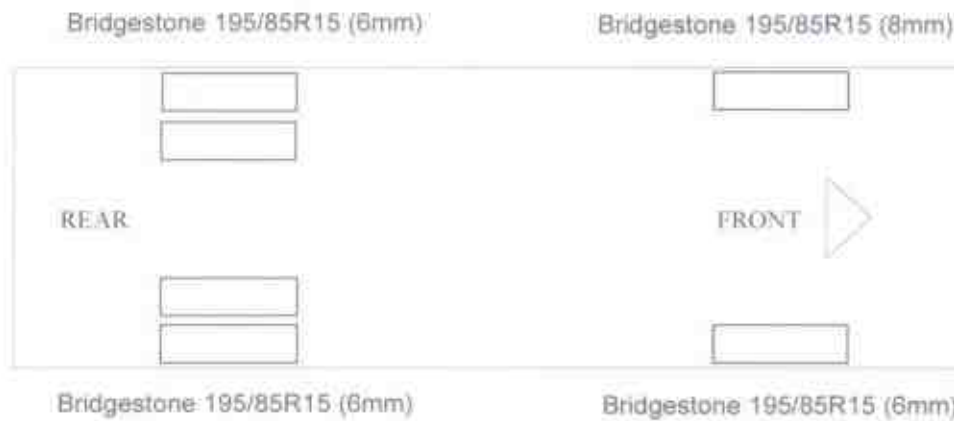
6. The 2 front tyres and 4 rear tyres of the Motor Lorry were observed to be in serviceable condition and sufficiently inflated for vehicular operation. We did not find any tear, cut or burst mark(s) on the outer and the inner sidewalls as well as across the tread of the 6 tyres. The tyre brand, tyre size and remaining tread depth of the 6 tyres of the Motor Lorry were recorded as follows:-
