Your Ref: TP/IP/02367/2018  
Our Ref : CI/TPD18002843/D

14 February 2018

**MECHANICAL INSPECTION REPORT OF POLICE MOTOR CAR QX 1026S**

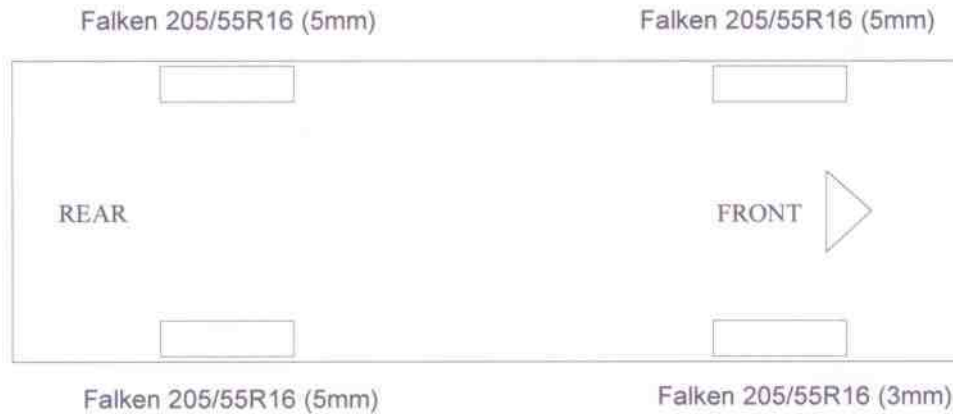
6. The condition of the Police Car's 4 tyres was observed to be in serviceable condition. I did not find any tear, cut or burst mark(s) on the outer and the inner sidewalls as well as across the tread of the 4 tyres. The 4 tyres were also observed to be sufficiently inflated for vehicular operation. The tyre brand, tyre size and remaining tread depth of the 4 tyres were recorded as follows:-
