Your Ref: TP/IP/09681/2017  
Our Ref : CI/TPD18004126/Z

05<sup>th</sup> March 2018

### **MECHANICAL INSPECTION REPORT OF MOTOR CAR SKA 2010Y**

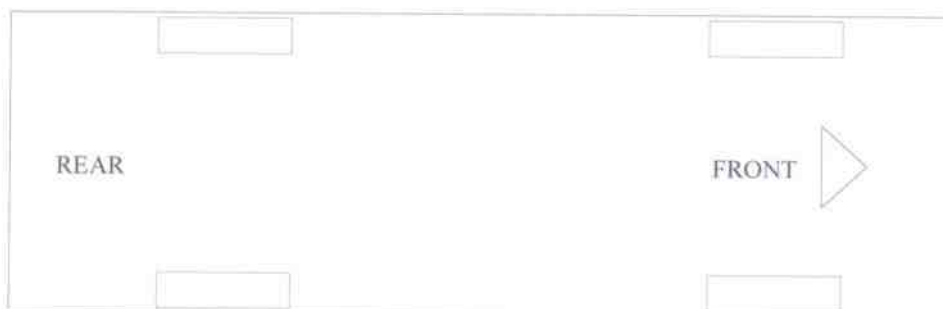
7. The condition of the Motor Car's 4 tyres were observed to be in serviceable condition. We did not find any tear, cut or burst mark(s) on the outer and the inner sidewalls as well as across the tread of the 4 tyres. The 4 tyres were also observed to be sufficiently inflated for vehicular operation. The tyre brand, tyre size and remaining tread depth of the 4 tyres were recorded as follows:-

Dunlop ENA Save EC300+ 215/60R17 (7mm)      Dunlop ENA Save EC300+ 215/60R17 (7mm)

Dunlop ENA Save EC300+ 215/60R17 (7mm)      Dunlop ENA Save EC300+ 215/60R17 (6mm)
