Your Ref : M533628  
Our Ref : CI/MSG18005184/N

9 February 2018

**AUTOMOBILE TECHNICAL INVESTIGATION REPORT OF ACCIDENT  
INVOLVING SHA 4304Y AND SKP 7941Z ON 20 OCTOBER 2017**

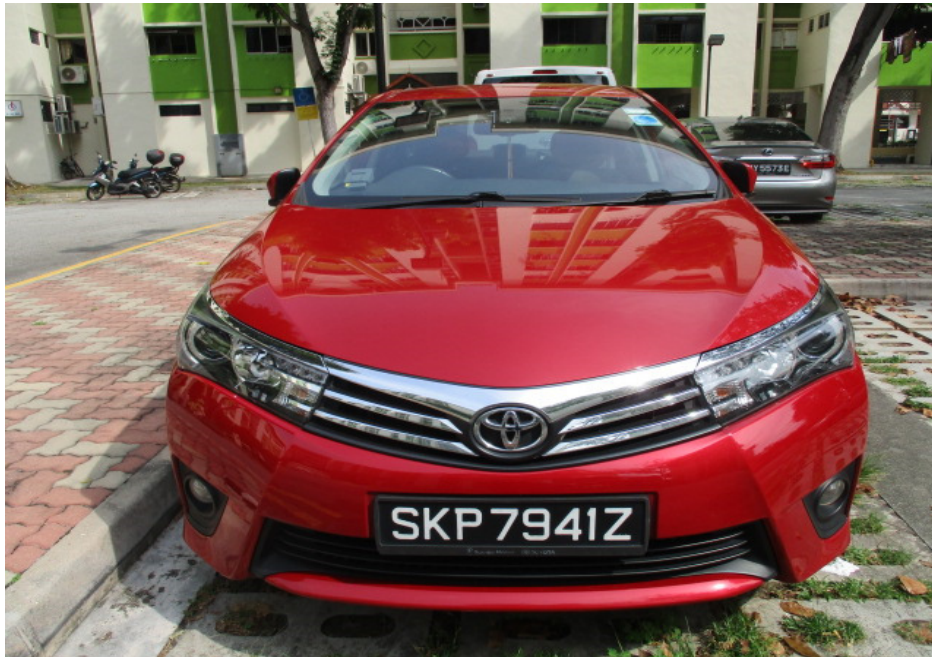
13. At the time of our inspection, we note that there was a slight distortion on the left side of the Toyota's front number plate frame, indicating that it had sustained an impact directly onto its front number plate frame. Closer examination had showed paint scratch marks and paint chips at the left portion of the front bumper, above the air vent. We also observed faint paint graze marks on the front left portion of the Toyota. However it was noted that the front bumper was not misaligned at its corner edges. See photos 3 - 10 below.

**Photo 3** shows the general view of the front portion of the Toyota at the time of our inspection.
