Auto
Consultants
Pte Ltd

Your Ref : 76171
Our Ref : CI/DAI18006786/Z

17th April 2018

**TECHNICAL INVESTIGATION REPORT OF FIRE INCIDENT INVOLVING THE
INSURED VEHICLE SFV 6655J ON 06th April 2018**

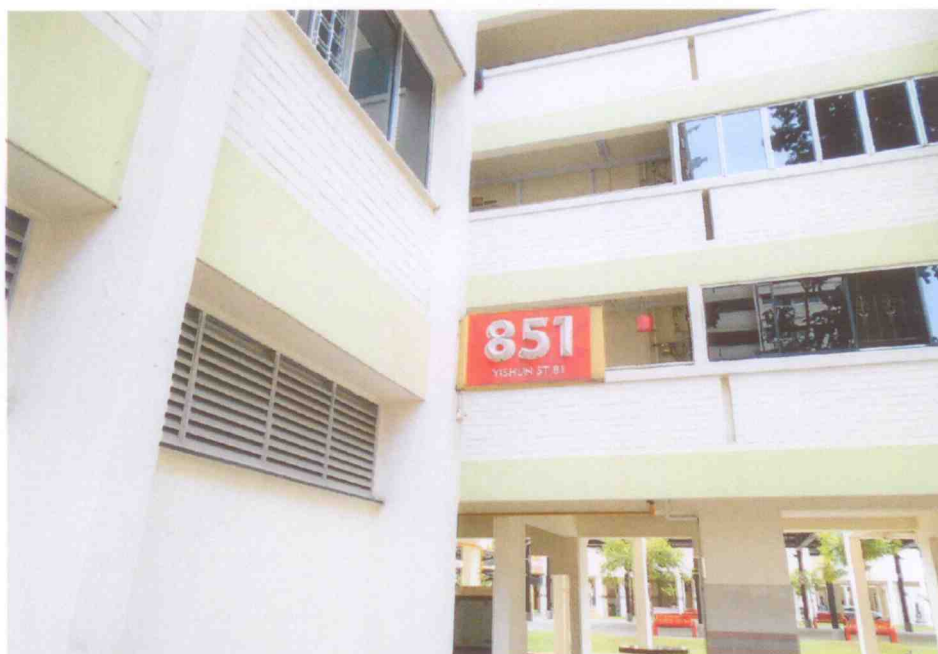
Photo 11 shows the general view of block 851 beside the open carpark where the Insured Vehicle was parked at the time of incident.
