Auto  
Consultants  
Pte Ltd

Your Ref : 76171  
Our Ref : CI/DAI18006786/Z

17<sup>th</sup> April 2018

**TECHNICAL INVESTIGATION REPORT OF FIRE INCIDENT INVOLVING THE  
INSURED VEHICLE SFV 6655J ON 06<sup>th</sup> April 2018**

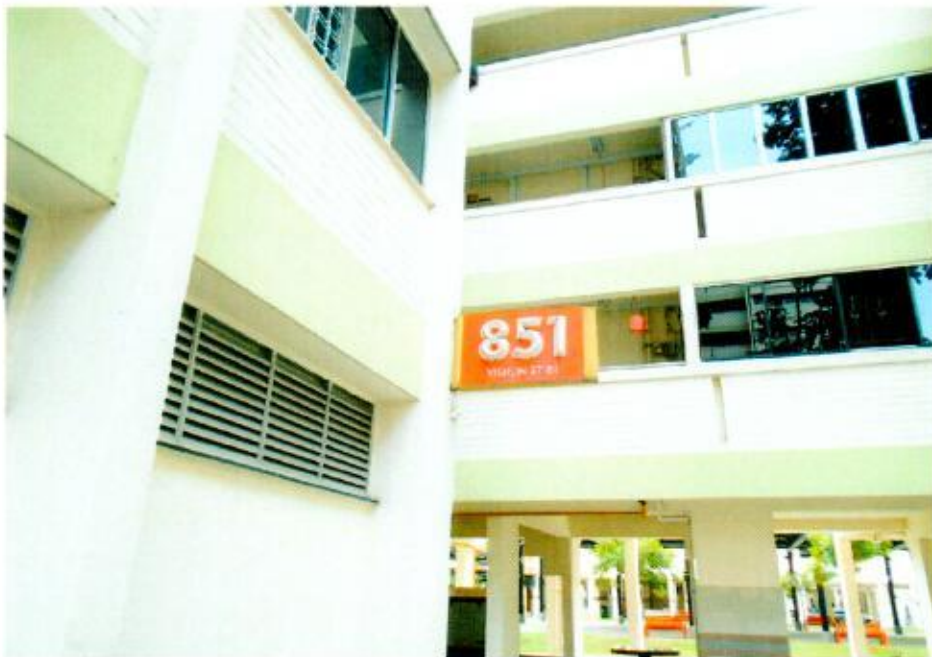
**Photo 11** shows the general view of block 851 beside the open carpark where the Insured Vehicle was parked at the time of incident.

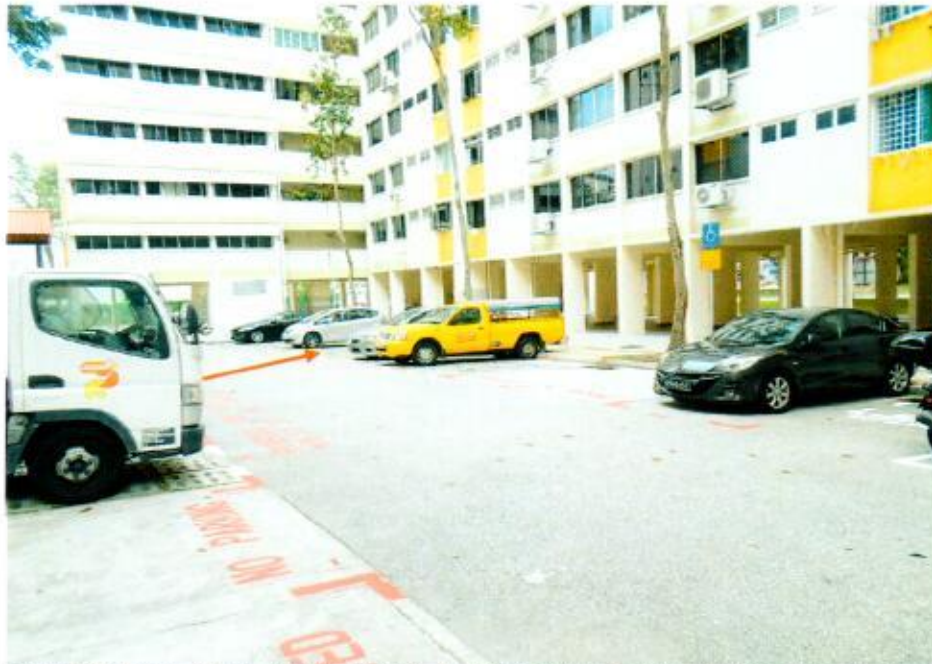
Photo 12 shows the general view of where the Insured Vehicle was parked (arrowed) at the time of incident. This was inside parking lot 109, which is on the right side upon entering the open car park.

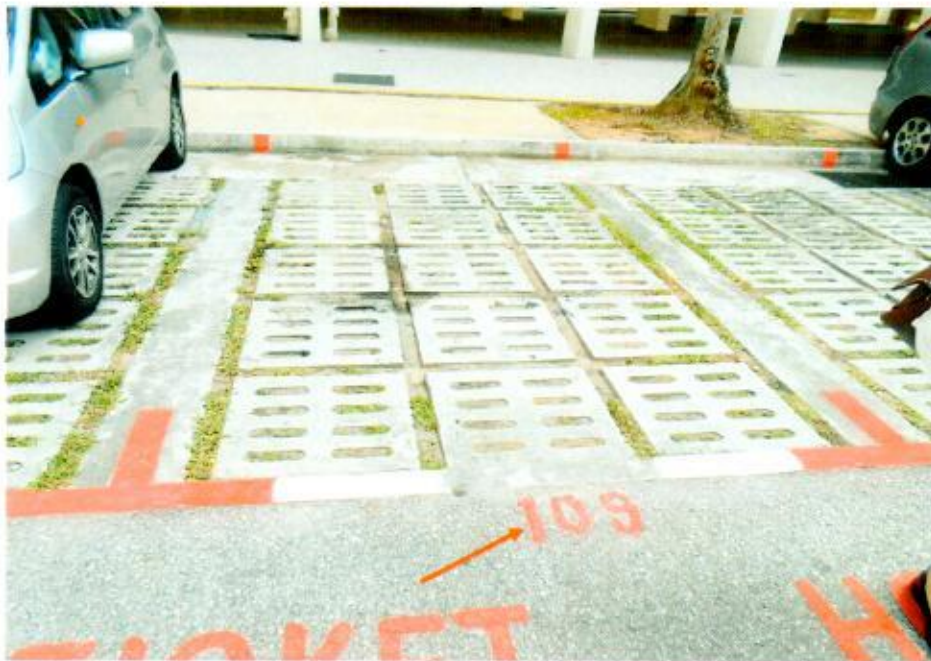
Photo 13 shows the general view of where the Insured Vehicle was parked (arrowed) at the time of incident. This was inside parking lot 109, which is on the right side upon entering the open car park.

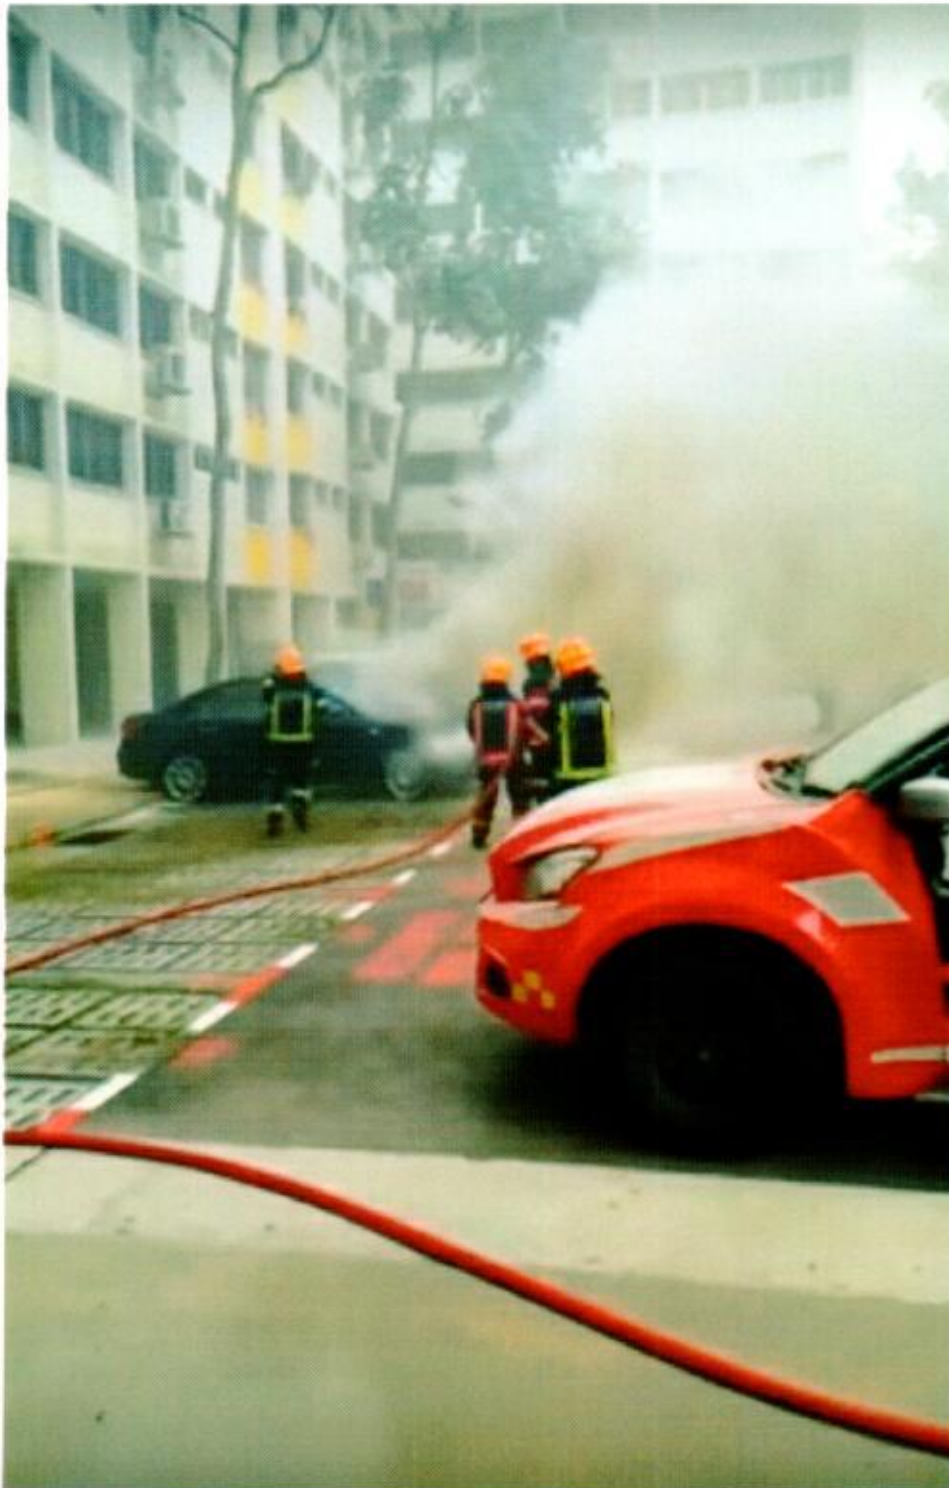
**Photo 15** shows the Insured Vehicle at the incident scene. SCDF fire fighters were seen trying to extinguish the fire from the Insured Vehicle.

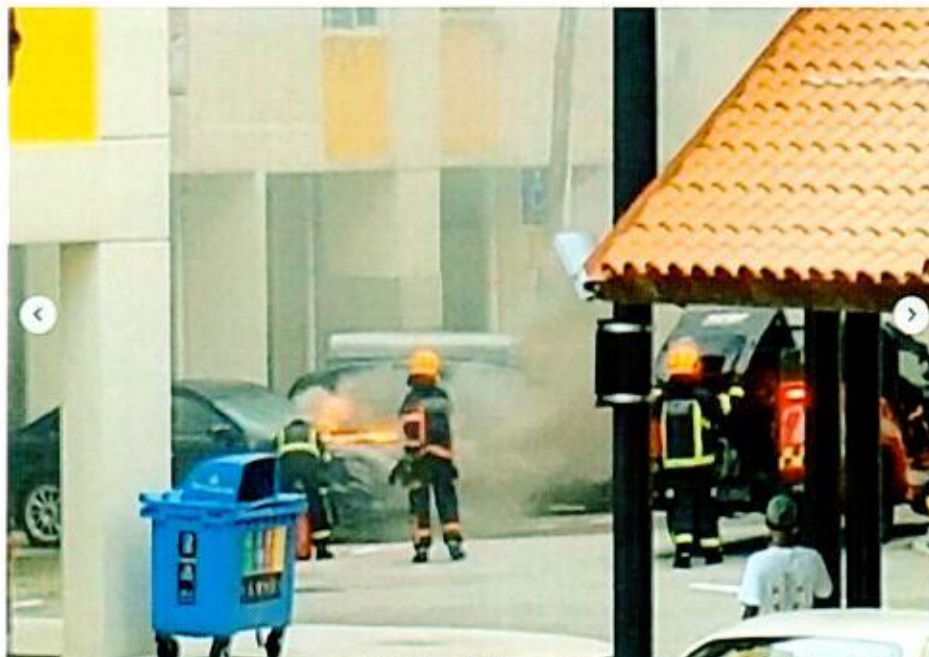
**Photo 16** shows the Insured Vehicle at the incident scene. SCDF fire fighters were seen trying to extinguish the fire from the Insured Vehicle.
