INVESTIGATION REPORT:

Our Ref : CS/ASM18006969/N

Claim No : S8M00DB8

Insured : SBE 75J

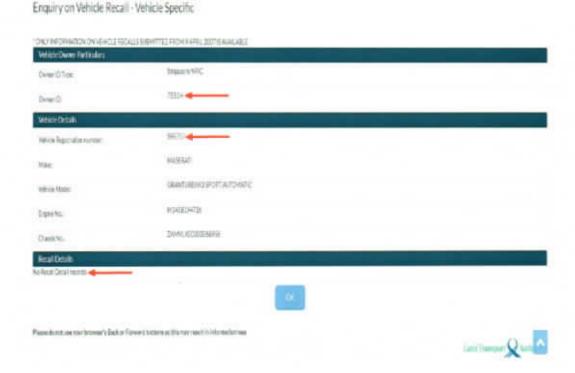
14. Our checks with both local and international bodies and associations had revealed that at the time of writing this report, there is no manufacturer recall of any nature to similar make and model vehicle as the Insured Vehicle that may possibly be related to this incident. See search result from LTA below.

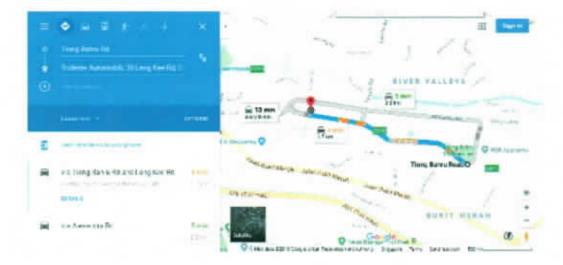
The location of Tridente Automobili from the accident location is approximately 1.7km as per the photo below.

We are of the opinion that driving the Insured Vehicle in that short distance is unlikely to cause damage to the engine or cooling system as these parts were not damaged based on the repair estimate which I have explained in my previous email.
