Your Ref : GA219427
Our Ref : CS/ASM18007192/Z

19th April 2018

TECHNICAL INVESTIGATION REPORT OF FIRE INCIDENT INVOLVING THE INSURED VEHICLE SGV 4954Y ON 20th March 2018

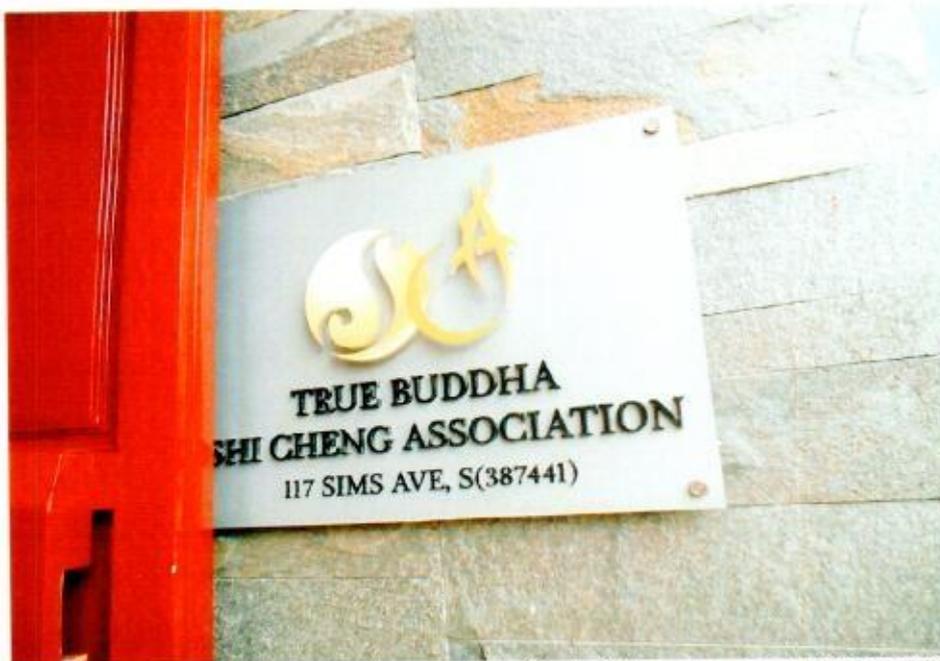
Photo 15 shows the Temple signage at the front of the open car park where the Insured Vehicle was parked at the time of incident.

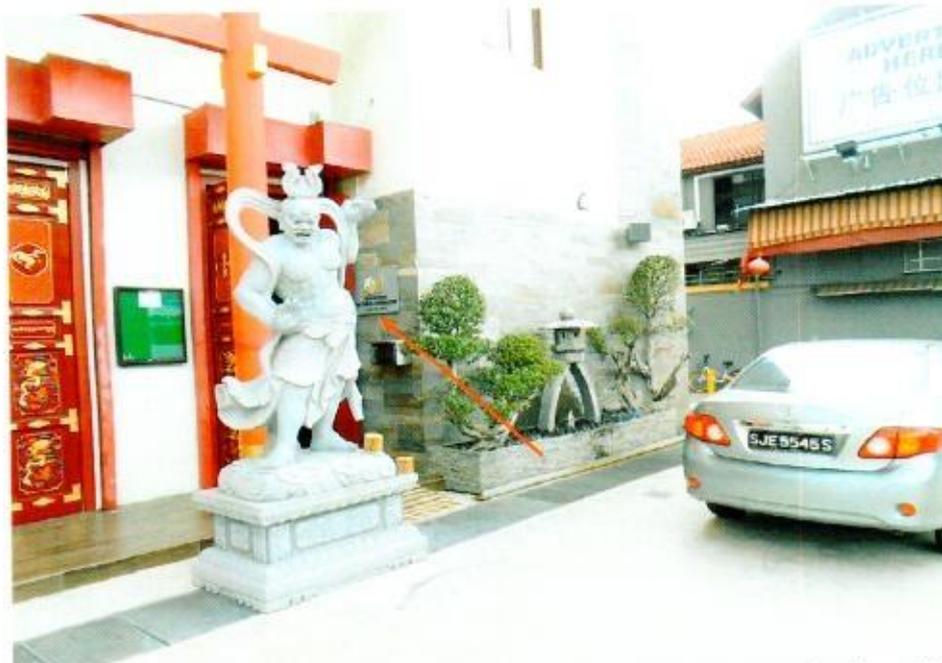
Photo 16 shows the Temple signage at the front of the open car park where the Insured Vehicle was parked at the time of incident.
