SUPPLEMENTARY COST OF REPAIRS TO AUDI A4 SLF1227H

## VEHICLE DAMAGE INSPECTION REPORT

Our File No: CS/MSG18007365/KRBE2

Handling Insurer: MSIG Insurance (Singapore) Pte. Ltd.	Policy No: A80310530QMY
Claimant Vehicle No: SLF1227H	Insured Vehicle No: SCJ8685H
Date of Loss: 19/04/2018	Nature of Claim: TP Claim No: 556123

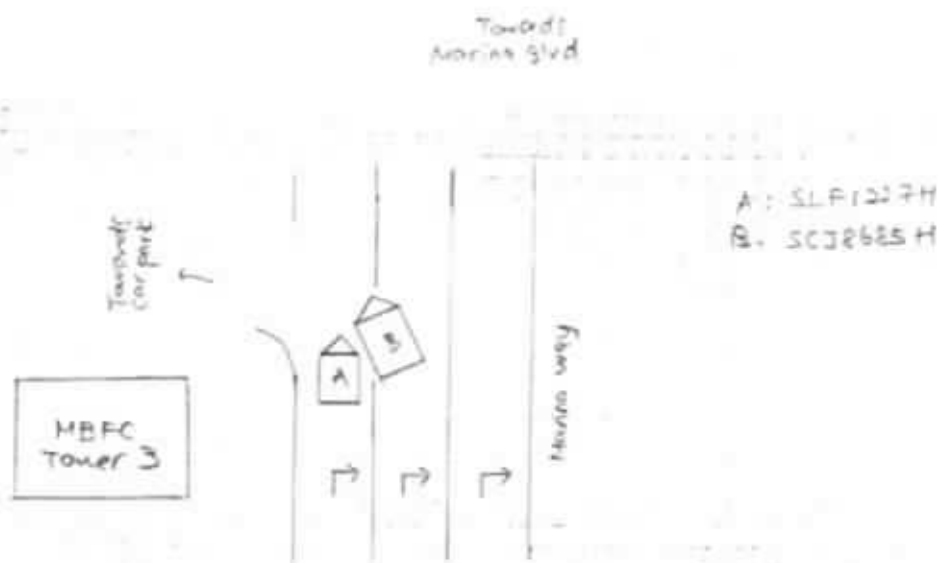
## SKETCH PLAN

on 10th April 2018, at about 0845hrs, I was travelling on the left most lane of Marina Way, intending to head down to turn into Marina Blvd ahead. Just at the entrance of MBFC Tower 3, a vehicle SCJ8685H, suddenly cut into my lane from my RHS, and hit my front RH portion of my vehicle. we then proceeded into the car park to exchange details.
