Your Ref: TP/IP/01231/2018
Our Ref : CI/TPD18008684/Z

MECHANICAL INSPECTION REPORT OF MOTOR CAR SLA 7573U

1. We refer to your request on 13th April 2018 to conduct a physical inspection of a motor car bearing registration number SLA 7573U (herein referred to as "Motor Car"), which was involved in a fatal road traffic accident on 06th January 2018.
2. The objective of the inspection is to determine if there was any possible mechanical failure to the Motor Car that may have contributed to the accident.
3. Following the request, we had carried out a physical inspection of the Motor Car on 08th May 2018 at the premises of Traffic Police vehicle pound, 517 Airport Road Singapore 539942. We now set out below our observations and comments with respect to this inspection.

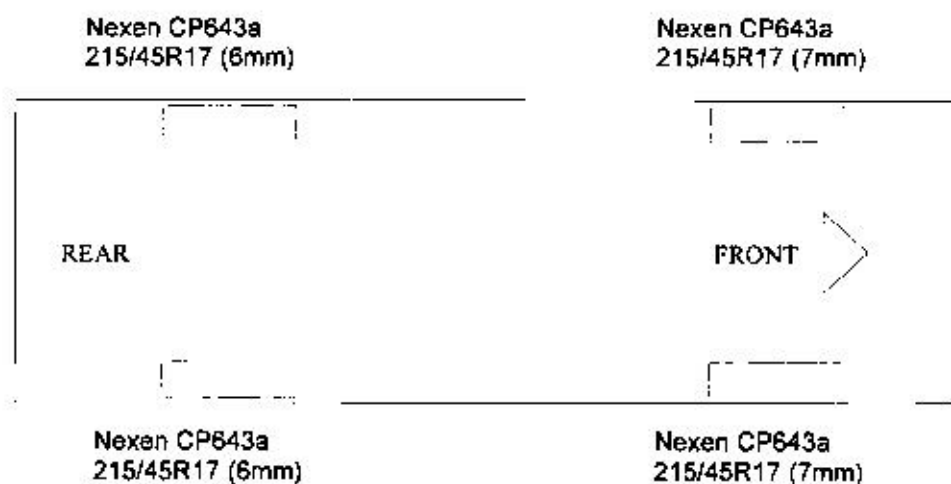
7. The condition of the Motor Car's 4 tyres was observed to be in serviceable condition. We did not find any tear, cut or burst mark(s) on the outer and the inner sidewalls as well as across the tread of the 4 tyres. The 4 tyres were also observed to be sufficiently inflated for vehicular operation. The tyre brand, tyre size and remaining tread depth of the 4 tyres were recorded as follows:-
