Your Ref: TP/IP/06211/2017
Our Ref :CI/TPD18008709/Z

28th February 2018

MECHANICAL INSPECTION REPORT OF MOTORCYCLE FBH 8168G

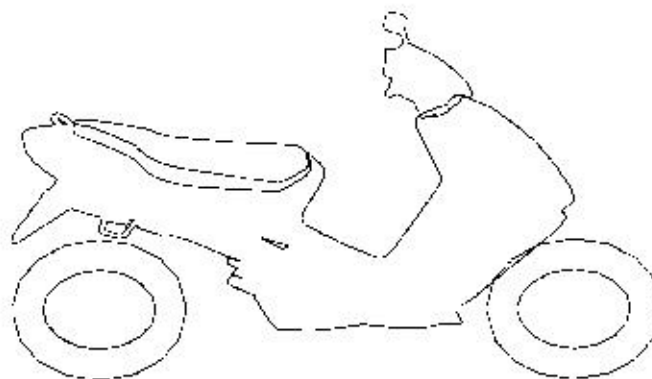
7. The conditions of the Motorcycle's tyres were observed to be in serviceable condition. The tread pattern of the 2 tyres was clearly visible. We did not observe any tear, burst mark(s) and/or punctured hole(s) on the sidewalls as well as across the tread of the 2 tyres. Both tyres were observed to be sufficiently inflated for vehicular operation. The tyre brand, tyre size and remaining tread depth of the 2 tyres were recorded as follows:-

Pirelli 140/70 - 17 (6mm)

Pirelli 100/80 - 17 (4mm)
