Your Ref : 2100352154-04
Our Ref : CI/AIG18009117/Z

23th May 2018

TECHNICAL INVESTIGATION REPORT OF FIRE INCIDENT INVOLVING THE INSURED VEHICLE SJY 7966S ON 12th May 2018

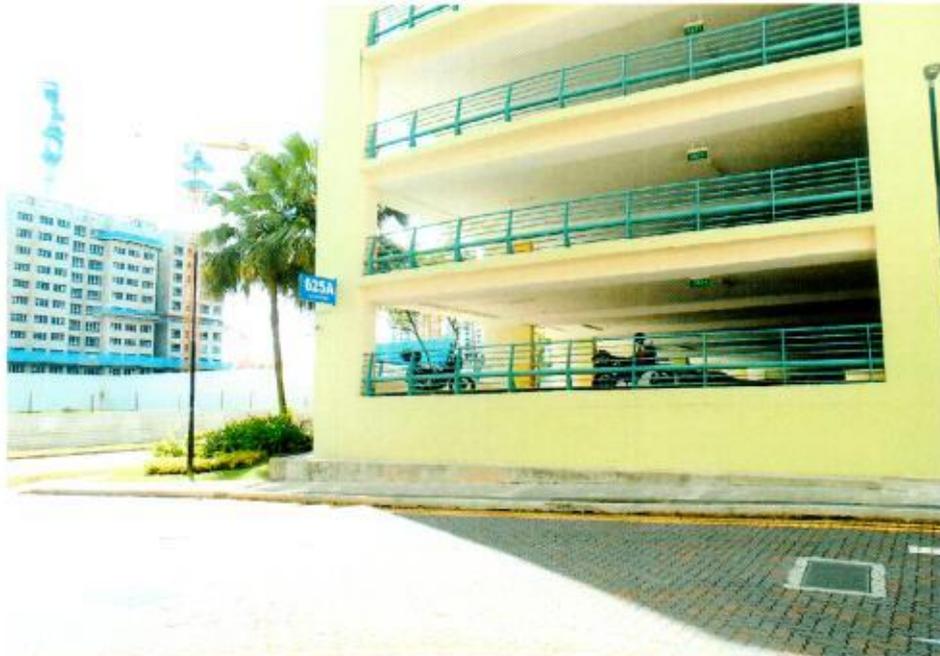
Photo 11 shows the general view of block 625A, a Multi-Storey car park where the Insured Vehicle was parked at the time of incident.

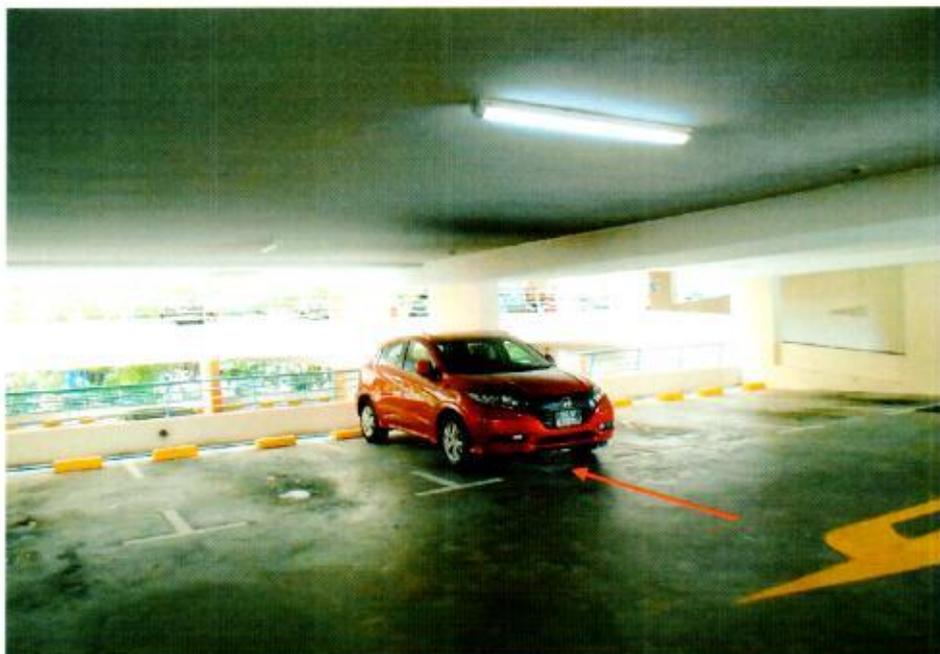
Photo 12 shows the general view of where the Insured Vehicle was parked (arrowed) at the time of incident. This was inside parking lot 290, which is on the right side upon entering Deck 3A of the Multi-Storey car park.

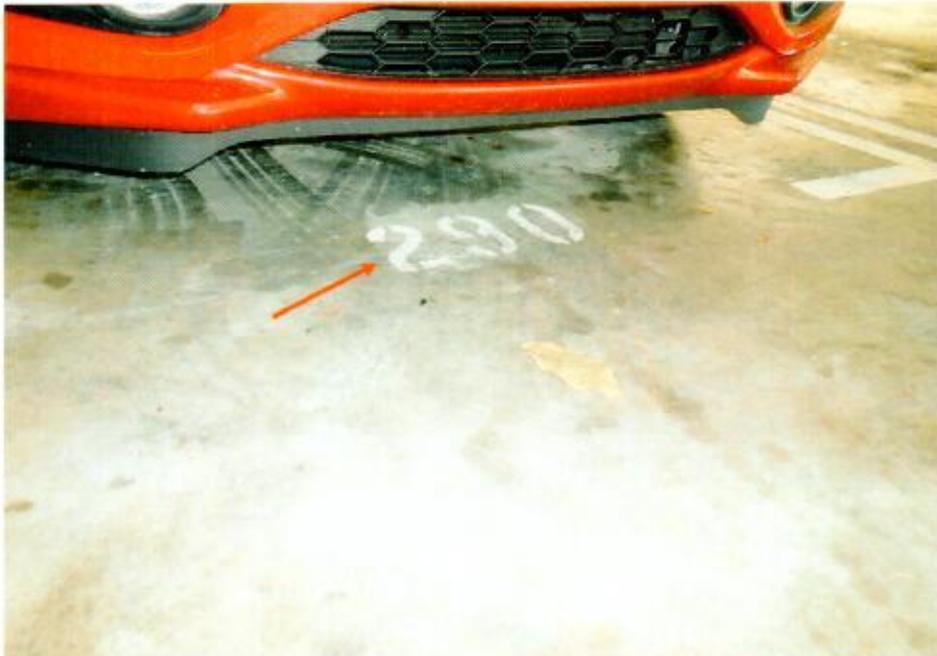
Photo 13 shows the general view of where the Insured Vehicle was parked (arrowed) at the time of incident. This was inside parking lot 290.
