INVESTIGATION REPORT:

Our Ref : CI/EQI18009124/N
Claim No : DM18HO00977-JG
Insured : YL 1675L
Date of Accident : 12 April 2018
Location : Carpark of Tanjong Pagar Distripark

Interview Summary of the Driver of the Insured Vehicle YL 1675L

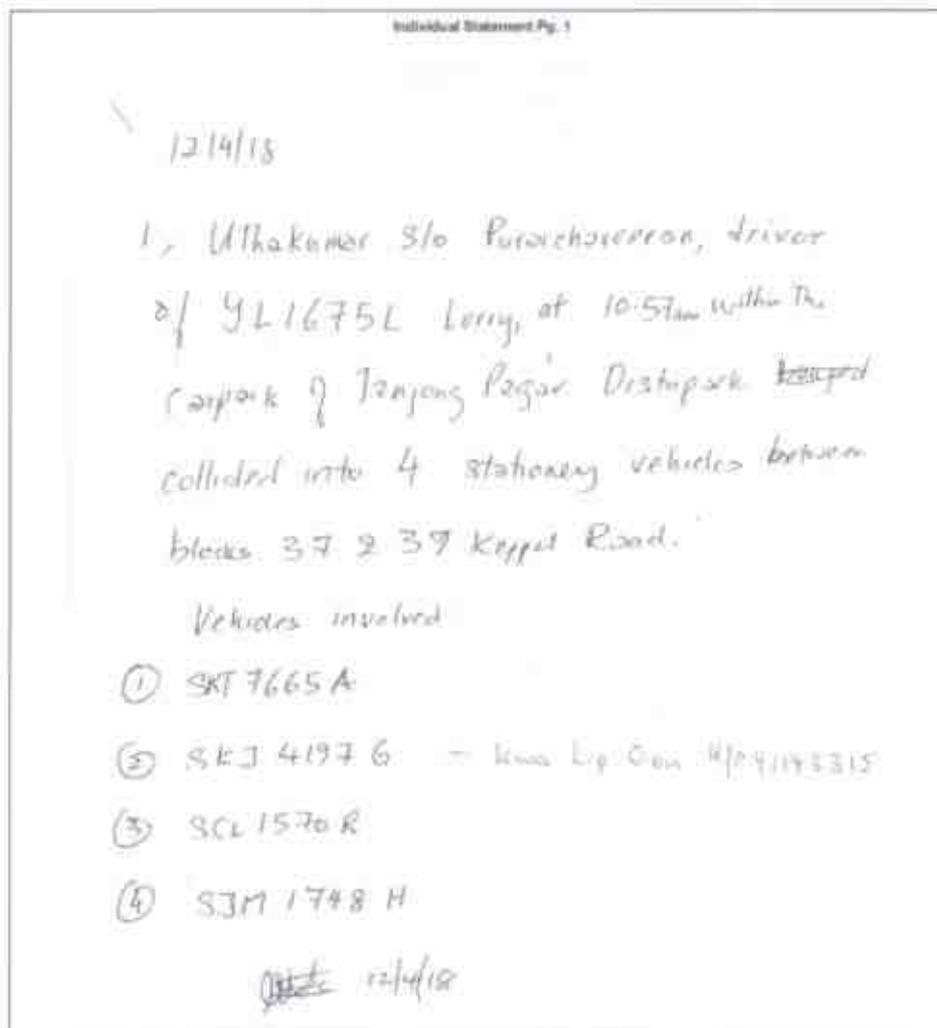
Photo 1 shows the written statement which was discussed and agreed by all 4 vehicle owners. The owner of the Toyota, Mr Kwa drafted the statement and asked Mr Kumar to sign it, which stated that he had driven the Insured Vehicle inside the TPD and collided into all 4 vehicles at the material date and time of accident.

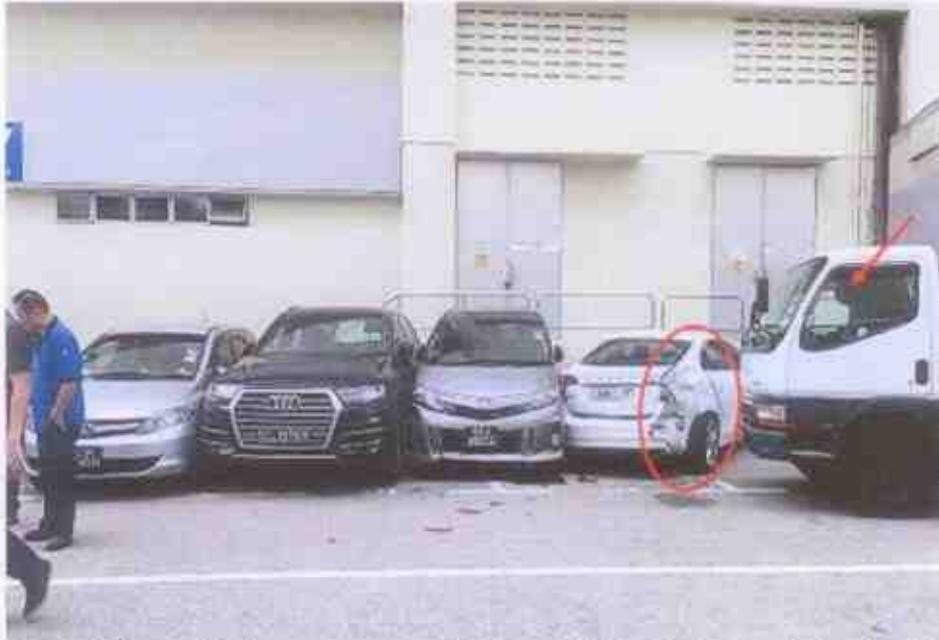
18. We managed to obtain a photograph of the Insured Vehicle being driven by Mr Kumar post-accident. It showed Mr Kumar reversing the Insured Vehicle to allow Ms Quek to take photographs of the damages sustained to the Volvo as a result of the accident. Our observation of Mr Kumar's ability to be able to still drive the Insured Vehicle post- accident would suggest that there was no drink driving involved in this particular accident. See photo 9 below.

Photo 9 shows Mr Kumar reversing the Insured Vehicle (arrowed) to allow Ms Quek to take photographs of the damages sustained to the Volvo as a result of the accident (circled). Our observation of Mr Kumar's ability to be able to still drive the Insured Vehicle post- accident would suggest that there was no drink driving involved in this particular accident.
