Your Ref: TP/IP/09695/2018
Our Ref :CI/TPD18010470/Z

Fatal Accident Investigation Team

MECHANICAL INSPECTION REPORT OF MOTORCYCLE MCU 4806

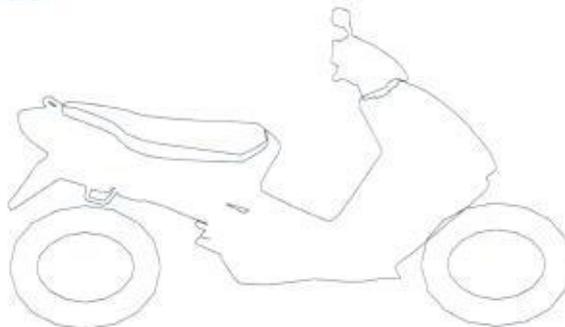
7. The condition of the Motorcycle's rear tyre was observed to be in serviceable condition whereas the front tyre found to be deflated likely due to the accident impact. The tread pattern of the 2 tyres was clearly visible. We did not observe any tear, burst mark(s) and/or punctured hole(s) on the sidewalls as well as across the tread of the 2 tyres. Further observation on the front tyre that was deflated at time of our inspection which is due to a missing tyre plug (for air inlet) from the front rim likely caused by the accident's collision impact. The rear tyre was observed to be sufficiently inflated for vehicular operation. The tyre brand, tyre size and remaining tread depth of the 2 tyres were recorded as follows:-

Cheetah 70/90 - 17 (3mm)

Cheetah 70/90 - 17 (4mm)
