Your Ref: TP/IP/26753/2018
Our Ref : CI/TPD18010659/Z

Fatal Accident Investigation Team

MECHANICAL INSPECTION REPORT OF MOTOR TAXI SHD 9756C

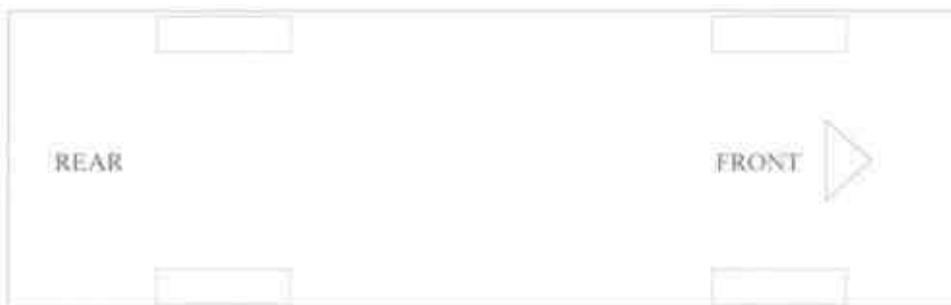
- The condition of the Motor Taxi's 4 tyres was observed to be in serviceable condition. We did not find any tear, cut or burst mark(s) on the outer and the inner sidewalls as well as across the tread of the 4 tyres. The 4 tyres were also observed to be sufficiently inflated for vehicular operation. The tyre brand, tyre size and remaining tread depth of the 4 tyres were recorded as follows:-

Good Year Excellence 215/60R16 (5mm)

Giti Comfort T20 215/60R16 (5mm)

Giti Comfort T20 215/60R16 (6mm)
