Your Ref: TP/IP/15135/2018
Our Ref : CI/TPD18010660/Z

10th May 2018

MECHANICAL INSPECTION REPORT OF MOTOR TAXI SHC 4294G

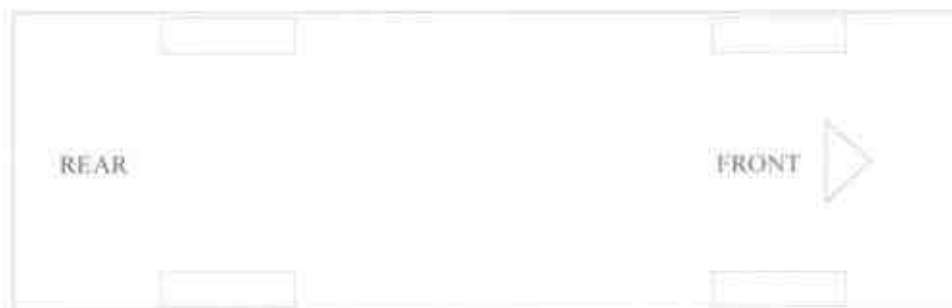
6. The conditions of the Motor Taxi's 3 tyres (front left, right & rear right tyres) were observed to be in serviceable condition with sufficiently inflated for vehicular operation. We did not find any tear, cut or burst mark(s) on the outer and the inner sidewalls as well as across the tread of the 3 tyres. As for the rear left tyre, it was found to be deflated likely due to the accident. Further observation found that the tyre was torn on the outer sidewalls. The tyre brand, tyre size and remaining tread depth of the 4 tyres were recorded as follows:-

Falken Sincera SM832
195/65R175 (7mm) (Deflated)

Falken Sincera SM832
195/65R175 (7mm)

Falken Sincera SM832
195/65R175 (5mm)
