MECHANICAL INSPECTION REPORT OF MOTOR CAR SJG 4315K

1. We refer to your request on 20th June 2018 to conduct a physical inspection of a motor car bearing registration number SJG 4315K (herein referred to as "**Motor Car**"), which was involved in a fatal road traffic accident on 14th May 2018.
2. The objective of the inspection is to determine if there was any possible mechanical failure to the Motor Car that may have contributed to the accident.
3. Following the request, we had carried out a physical inspection of the Motor Car on 20th July 2018 at the premises of Traffic Police vehicle pound, 517 Airport Road Singapore 539942. We now set out below our observations and comments with respect to this inspection.

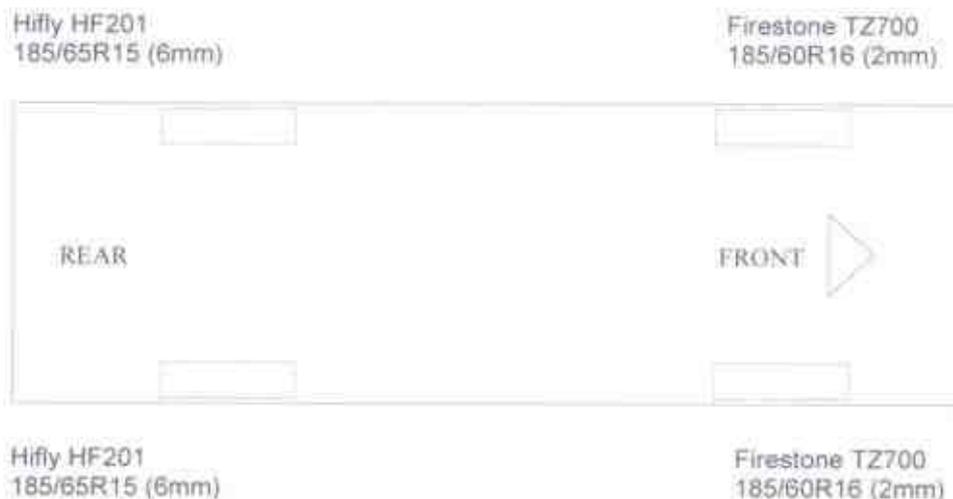
7. The condition of the Motor Car's 4 tyres was observed to be in serviceable condition. We did not find any tear, cut or burst mark(s) on the outer and the inner sidewalls as well as across the tread of the 4 tyres. The 4 tyres were also observed to be sufficiently inflated for vehicular operation. The tyre brand, tyre size and remaining tread depth of the 4 tyres were recorded as follows:-

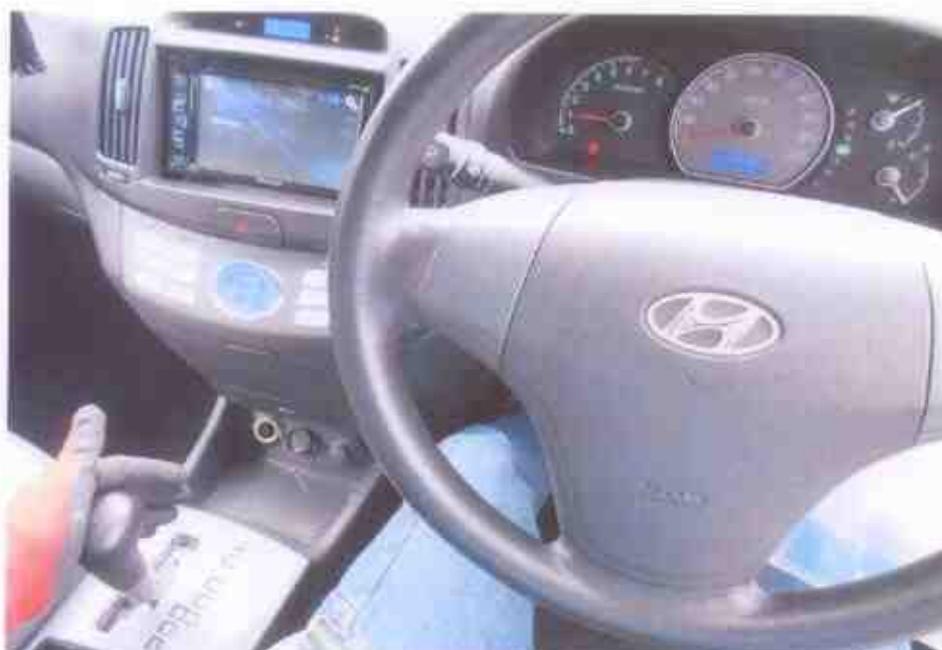
15. A short operational test of the Motor Car, to primarily determine whether there was any abnormality to its engine system, its transmission system and braking system was subsequently carried out.
16. During the operational test, the transmission system of the Motor Car was able to be shifted to drive mode and reverse mode without any difficulty. There were no abnormal sounds heard and/or abnormal behaviour of the Motor Car's engine system. It was able to move forward and backward normally. The braking system was also found to be in working condition as the Motor Car was able to slow down and come to a complete stop upon depressing of the brake pedal. See photo 24 & 26 below.

Photo 24 shows a short operational test of the Motor Car, to primarily determine whether there was any abnormality to its engine system, its transmission system and braking system was subsequently carried out.

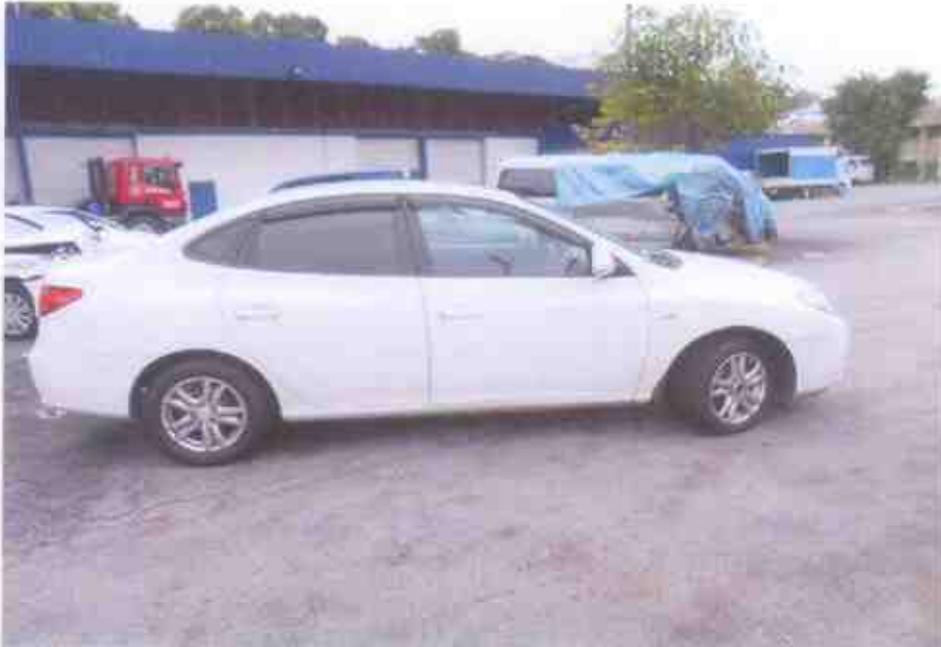
Photo 25 shows a short operational test of the Motor Car, to primarily determine whether there was any abnormality to its engine system, its transmission system and braking system was subsequently carried out.

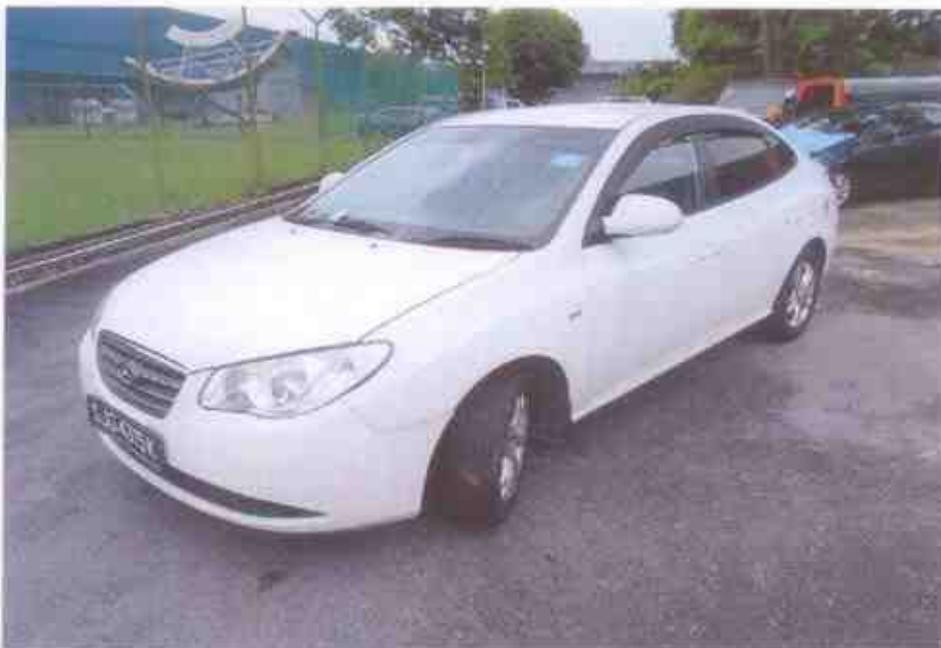
Photo 26 shows a short operational test of the Motor Car, to primarily determine whether there was any abnormality to its engine system, its transmission system and braking system was subsequently carried out.
