Your Ref: TP/IP/28005/2018
Our Ref : CI/TPD18011340/Z

17th August 2018

MECHANICAL INSPECTION REPORT OF MOTOR BUS SBS 8360J

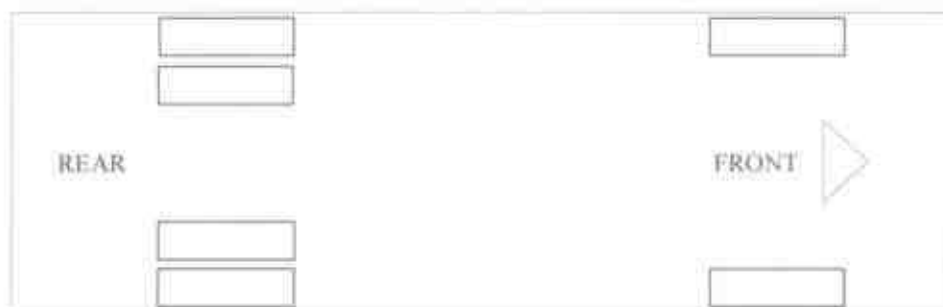
Bridgestone R192 275/70 R22.5 (8mm)

Bridgestone R192 275/70 R22.5 (9mm)

Bridgestone R192 275/70 R22.5 (6mm)

8. The 6 tyres were observed to be wrapped around standard alloy wheel rims that were found to be without any damage. See photo 8 – 11 below.

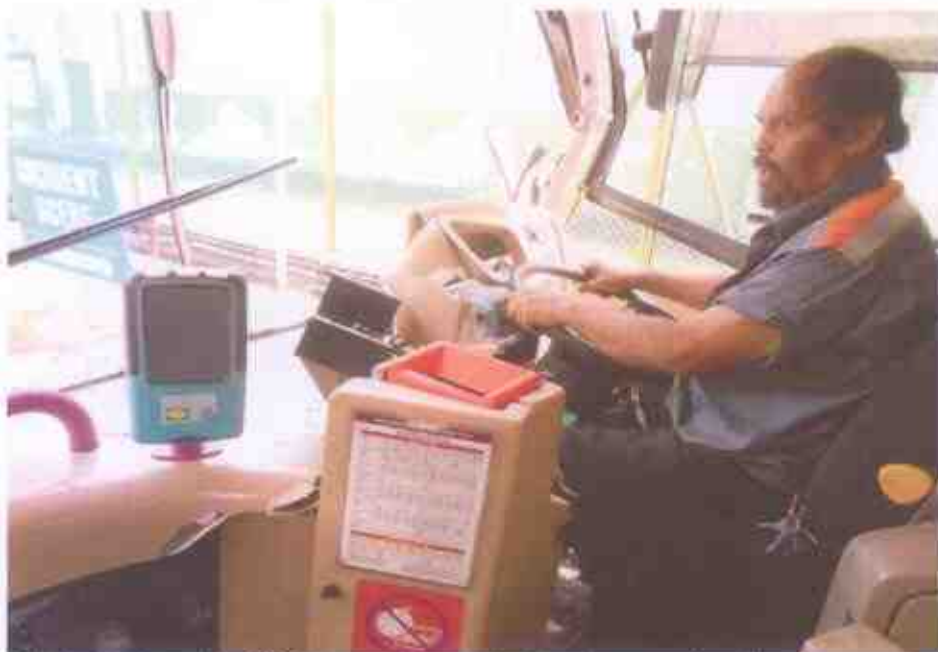
18. A short operational test of the Motor Bus, to primarily determine whether there was any abnormality to its various operating systems like its engine system, its transmission system, steering system and braking system was subsequently carried out by SBS representative. The test was conducted by driving the Motor Bus forward, stopping, before reversing and coming to a stop again.
19. During the operational test, the various transmission gears of the Motor Bus were able to be engaged without any difficulty by manually shifting the gear selector. There were no abnormal sounds heard and/or abnormal behaviour of the Motor Bus's engine system. It was able to move forward and backward normally. The braking system was found to be in working condition as the Motor Bus was able to slow down and come to a complete stop upon depressing of the brake pedal. See photo 27 & 28 below.

Photo 27 shows the SBS driver while conducting the operational test.
