Your Ref: TP/IP/26803/2018  
Our Ref : CI/TPD18011347/Z

20<sup>th</sup> August 2018

**Fatal Accident Investigation Team**

**MECHANICAL INSPECTION REPORT OF MOTOR LORRY YP 6558M**

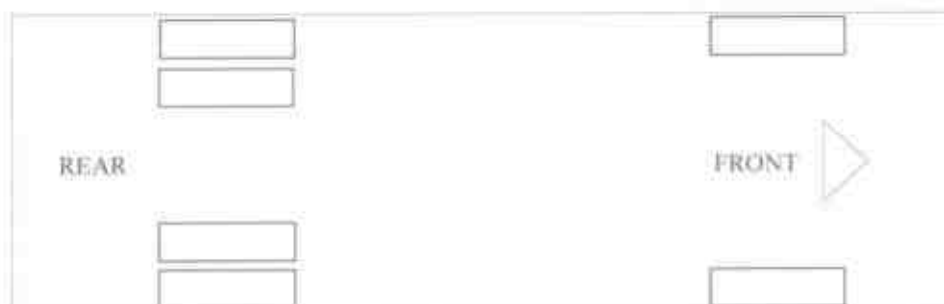
7. The 2 front tyres and 4 rear tyres of the Motor Lorry were observed to be in serviceable condition and sufficiently inflated for vehicular operation. We did not find any tear, cut or burst mark(s) on the outer and the inner sidewalls as well as across the tread of the 6 tyres. The tyre brand, tyre size and remaining tread depth of the 6 tyres of the Motor Lorry were recorded as follows:-

Bridgestone R294 275/70 R22.5 (8mm)

Bridgestone R294 275/70 R22.5 (7mm)

Bridgestone R294 275/70 R22.5 (9mm)
