Your Ref: TP/IP/02043/2018
Our Ref :CI/TPD18011351/Z

Fatal Accident Investigation Team
Traffic Police Department
Singapore Police Force
10 Ubi Avenue 3
Singapore 408865

MECHANICAL INSPECTION REPORT OF MOTORCYCLE JPW 6319

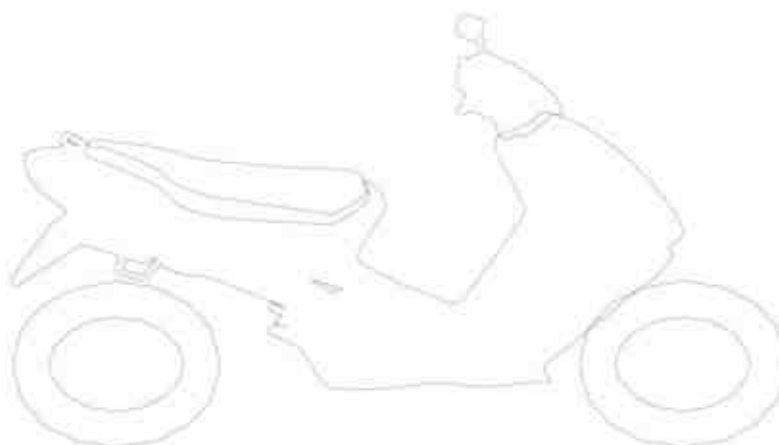
7. The condition of the Motorcycle's tyres was observed to be in serviceable condition. The tread pattern of the 2 tyres was clearly visible. We did not observe any tear, burst mark(s) and/or punctured hole(s) on the sidewalls as well as across the tread of the 2 tyres. Both tyres were observed to be sufficiently inflated for vehicular operation. The tyre brand, tyre size and remaining tread depth of the 2 tyres were recorded as follows:-

Michelin Pilot Street
140/70-17 (3mm)

Michelin Pilot Street
110/70-17 (3mm)
