Auto  
Consultants  
Pte Ltd

28<sup>th</sup> August 2018

**Fatal Accident Investigation Team**

**MECHANICAL INSPECTION REPORT OF MOTOR BUS SMB 1607D**

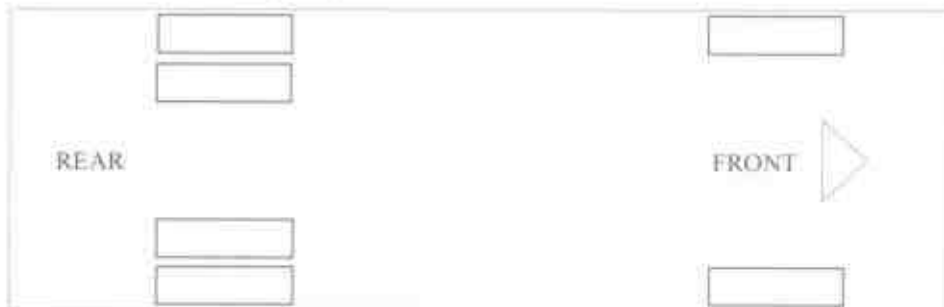
Bridgestone U-AP 275/70 R22.5 (8mm)

Firenza SSU05 275/70 R22.5 (9mm)

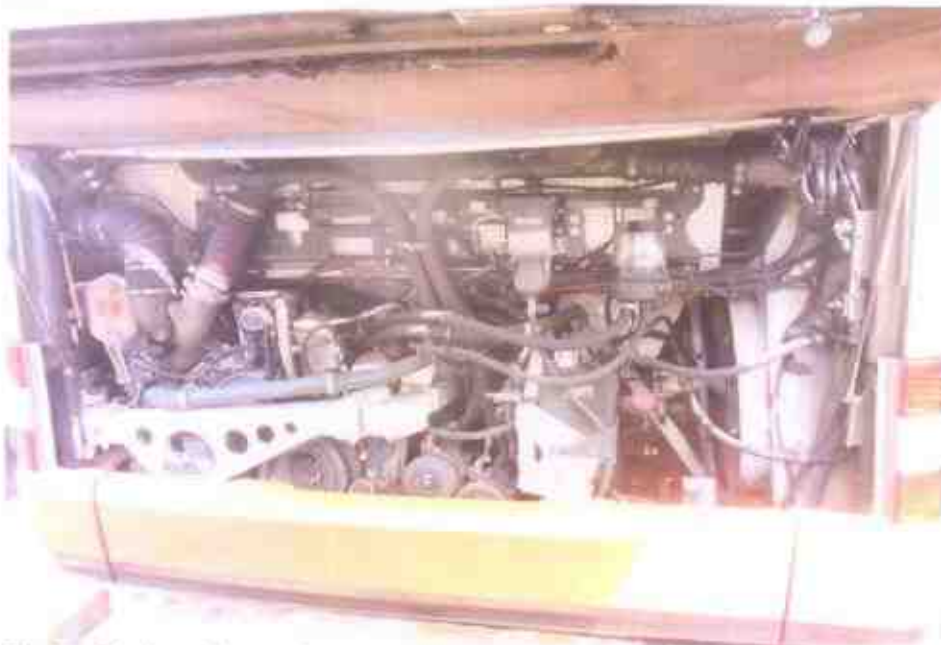
9. Upon examination of the engine compartment of the Motor Bus, we had observed all the parts and components inside the engine compartment to be intact and unaffected by the accident. The engine oil and steering fluid were all found to be of sufficient level for operating purposes. Visually, there was also no contamination found to these fluids.

10. Further examination of the engine compartment revealed no sign(s) or indication(s) of fluid leakage and/or fluid stain within the engine compartment of the Motor Bus.

**Photo 11** shows the engine compartment of the Motor Bus was located at the rear of the Motor Bus.

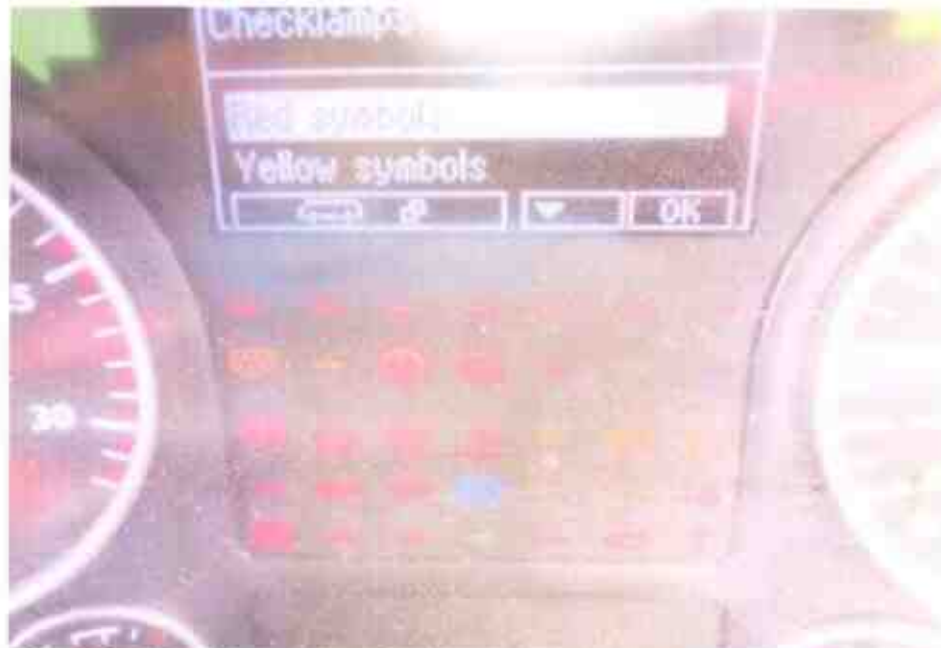
17. The Motor Bus's automatic self-test of the functionality of its various electronic operating systems like the Battery checked indicator, engine checked indicator, Anti-Locking Braking System ABS indicator, Parking light indicator & Diesel Particulate Filter Warning. During cranking of the engine had indicated that these systems were in working condition and without abnormality. This can be established from the warning lights disappearing from the instrument panel after the self-test. See photo 23 & 25 below.

**Photo 23** shows the warning lights for the various electronic operating systems of the Motor Bus appearing on its instrument panel during the self-test when the engine was cranked.

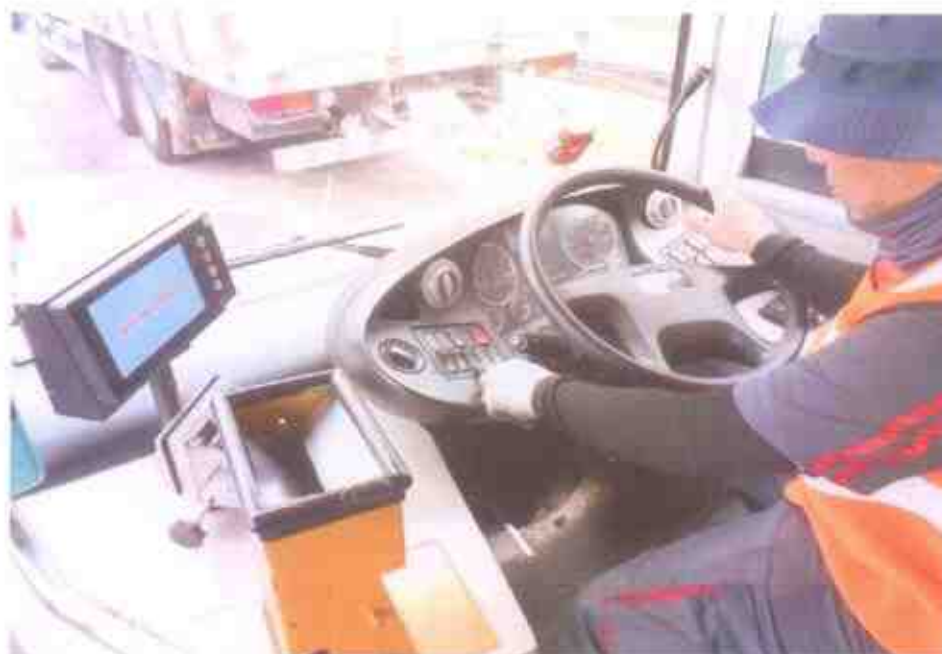
18. A short operational test of the Motor Bus, to primarily determine whether there was any abnormality to its various operating systems like its engine system, its transmission system, steering system and braking system was subsequently carried out by SMRT representative. The test was conducted by driving the Motor Bus forward, stopping, before reversing and coming to a stop again.
19. During the operational test, the various transmission gears of the Motor Bus were able to be engaged without any difficulty by manually shifting the gear selector. There were no abnormal sounds heard and/or abnormal behaviour of the Motor Bus's engine system. It was able to move forward and backward normally. The braking system was found to be in working condition as the Motor Bus was able to slow down and come to a complete stop upon depressing of the brake pedal. See photo 26 & 27 below.

Photo 26 shows the SMRT driver while conducting the operational test.
