Your Ref: TP/IP/32353/2018
Our Ref : CI/TPD18011356/Z

14th September 2018

MECHANICAL INSPECTION REPORT OF MOTOR LORRY GY 1421Y

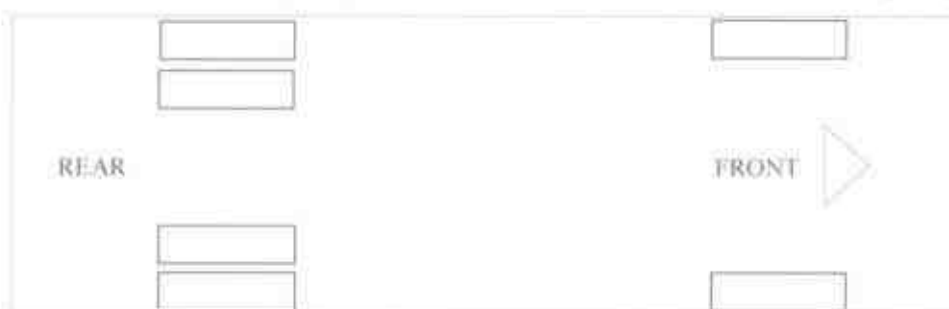
7. The 2 front tyres and 4 rear tyres of the Motor Lorry were observed to be in serviceable condition and sufficiently inflated for vehicular operation. We did not find any tear, cut or burst mark(s) on the outer and the inner sidewalls as well as across the tread of the 6 tyres. The tyre brand, tyre size and remaining tread depth of the 6 tyres of the Motor Lorry were recorded as follows:-

Condor AL308 155 R12c (5mm)

Condor AL228 195 R15c (6mm)

Condor AL228 195 R15c (5mm)
