Your Ref: TP/IP/35301/2018
Our Ref : CI/TPD18011457/Z

15th October 2018

MECHANICAL INSPECTION REPORT OF MINI MOTOR BUS PA 7839G.

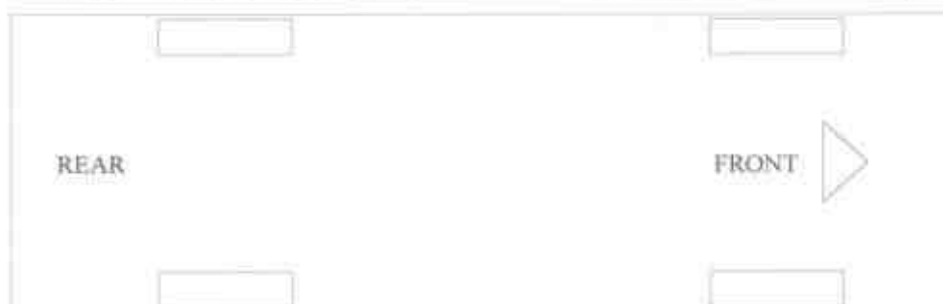
7. The 4 tyres were observed to be in serviceable condition and sufficiently inflated for vehicular operation. We did not find any tear, cut or burst mark(s) on the outer and the inner sidewalls as well as across the tread of the 4 tyres. The tyre brand, tyre size and remaining tread depth of the 4 tyres of the Motor Bus were recorded as follows:-

Maxtek SU-810 195 R15 LT (8mm)

CST Tires CL-31 195 R15 (7mm)
