RE: My car SGY9819G accident with Meres car ET9933J report and pictures

## 1. Policy Particulars :- THIRD PARTY CLAIM

## ADJUSTMENT ON REPAIR COST FOR VEHICLE NO. ET 9933J

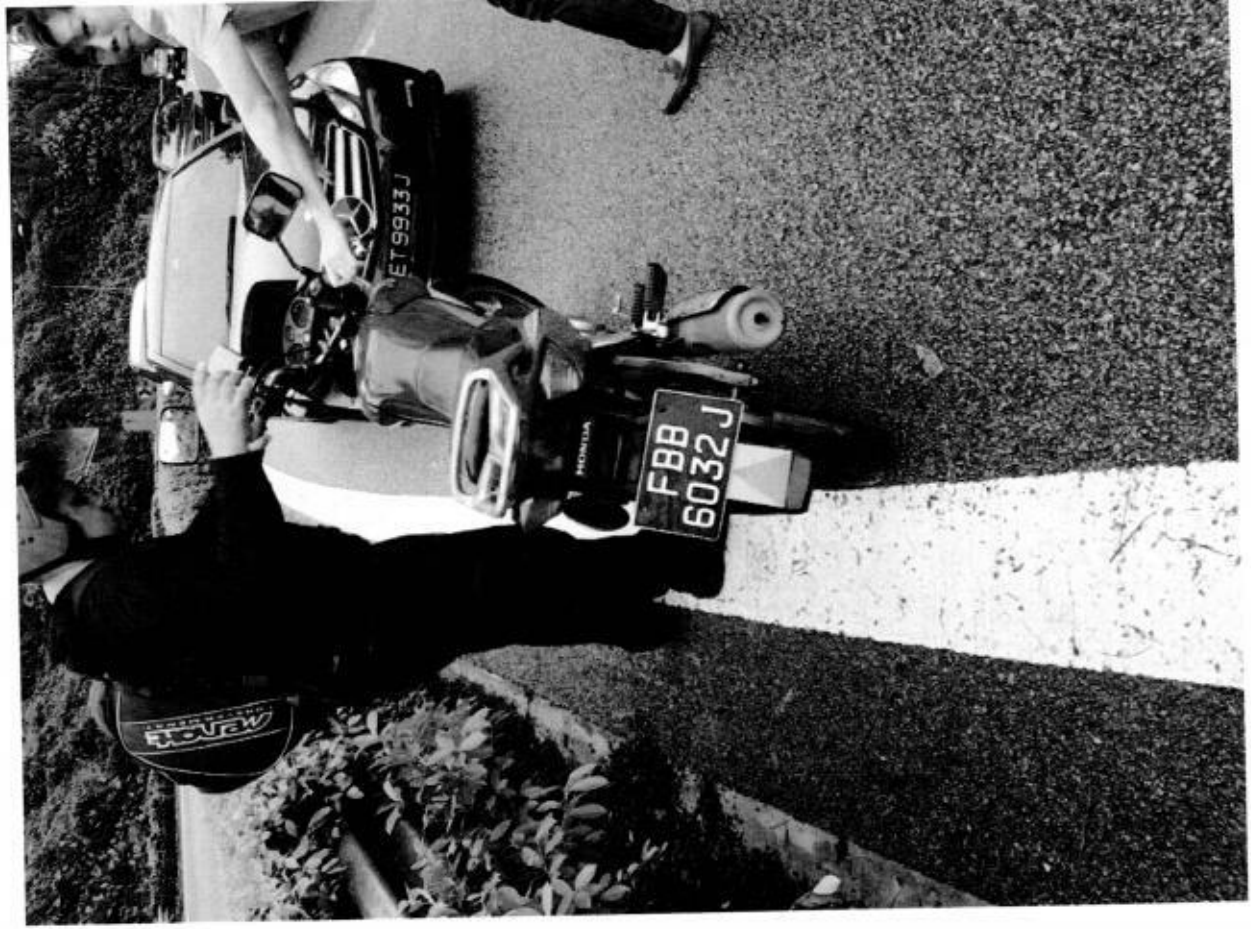
SKETCH PLAN

A-564901969  
B-679932J  
C-7AR-635J  
BKE

At grand equities to another, I was driving from BKE towards P1E TUN. Because it was raining the road is slippery. Bike 'C' skidded and fell at the end of car 'B' immediately emergency brake and could have hit bike 'C'. I also emergency brake, but my car hit car 'B' rear. My car that was damaged by the front metal of car 'B' Mercedes car the rear of Mercedes car 'B' was only slight dent and a bit crack only. Car 'B' Mercedes car could have hit bike 'C'. Car 'B' driver said there is some scratches in front. Both of us confirmed there was no injury. We helped bike 'C' to get up from his fall and assisted his bike to the shoulder. Car 'B' rear was slightly dented and no injury of the car 'B' driver and his passenger. I took some pictures of the slight dented rear of car 'B' and there are no damages on other parts of his car apart some clipped off and no injuries from car 'B' and bike 'C' who fell off on his own and biker was also not injured and all of us didn't ride from the scene. No matter what made us no injury car 'B' has no major damage except rear slight dent and clipped off.
