Your Ref: Honda Engine
Our Ref : CI/TP18012598/D

M/s Mega Car Pte Ltd
160 Sin Ming Drive #05-21
Sin Ming Autocity
Singapore 575722

INSPECTION REPORT OF A HONDA ENGINE

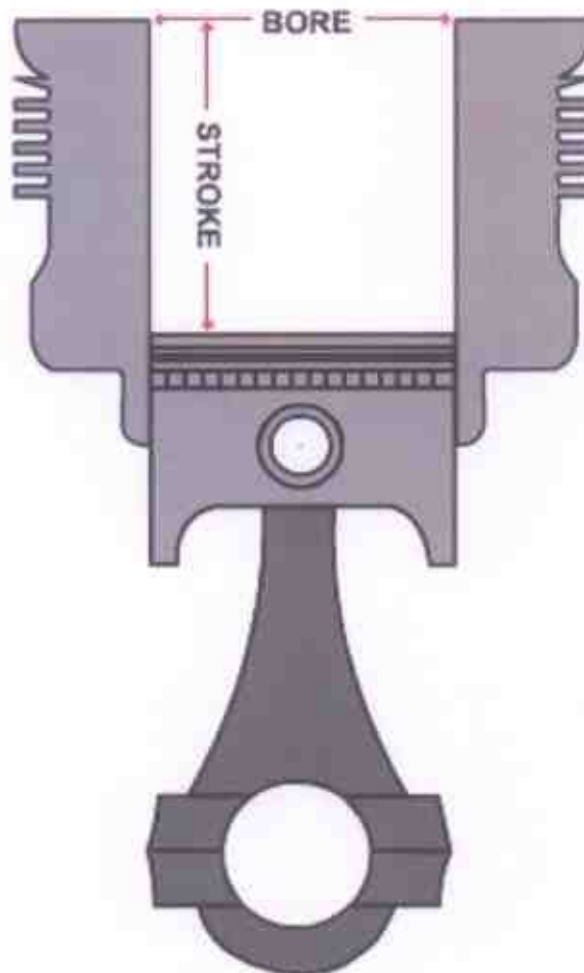
9. The bore refers to the measurement of the inside diameter of the cylinder while the stroke refers to the distance the piston moves in one direction of upward or downward movement in the cylinder. See diagram below for illustration purposes.
