Your Ref: Honda Engine Our Ref: CI/TP18012599/D

11 July 2018

#### INSPECTION REPORT OF A HONDA ENGINE

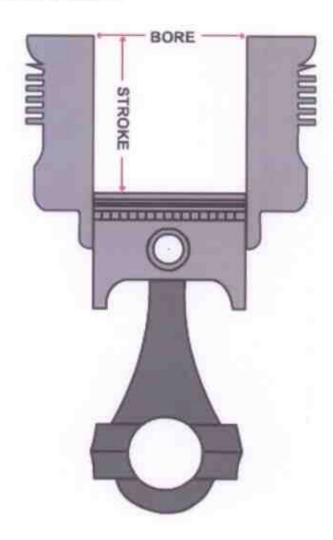
The bore of an engine refers to the measurement of the inside diameter of the cylinder while the stroke refers to the distance the piston moves in one direction of upward or downward movement in the cylinder. See diagram below for illustration purposes.
