Your Ref: TP/IP/18933/2018  
Our Ref : CI/TPD18012780/Z

**Fatal Accident Investigation Team**  
Traffic Police Department  
Singapore Police Force  
10 Ubi Avenue 3  
Singapore 408865

### **MECHANICAL INSPECTION REPORT OF MOTORCYCLE FBD 7456C**

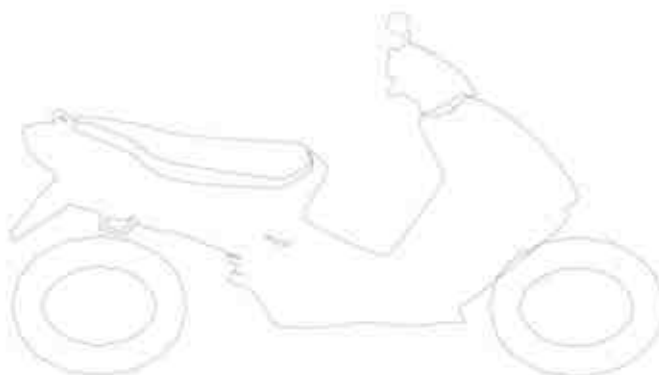
7. The condition of the Motorcycle's rear tyre was observed to be in serviceable condition whereas the front tyre was found to be deflated likely due to the accident impact. However, the tread pattern of the 2 tyres was clearly visible. We did not observe any tear, burst mark(s) and/or punctured hole(s) on the sidewalls as well as across the tread of the 2 tyres. The rear tyre was observed to be sufficiently inflated for vehicular operation. The tyre brand, tyre size and remaining tread depth of the 2 tyres were recorded as follows:-

Bridgestone 190/50 - 17 (3mm)

Bridgestone 120/70 - 17 (3mm)
