**From:** Veron Chen (LKKAuto)  
**Sent:** Monday, 16 September 2019 11:12 AM  
**To:** 'Alan Chng'  
**Cc:** Taufikh (LKKAuto); SUR  
**Subject:** FW: 1st reminder resend the finalization for veh no:WD158K  
**Attachments:** 06082019163145-0001.pdf; 06082019163128-0001.pdf

| CLAIM SUBFOLDER DETAILS | | [Created by insurer] |
|---|---|---|
| Vehicle Reg. No.: | WD158K | Date of Loss: 07/07/2018 05:00 - :59<br>[26 Months and 15 Days From LTA Reg Date (Man Yr)] |

## VEHICLE DAMAGE INSPECTION REPORT

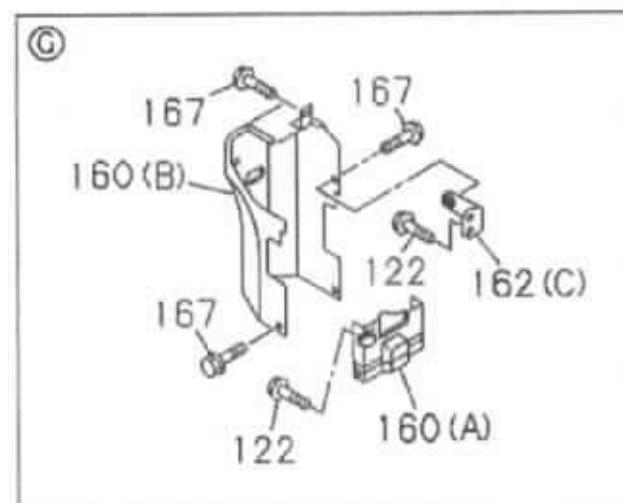
item - 224

| No. | Qty | Part No. | Particulars | Condition | Repairer's | Amount |
|---|---|---|---|---|---|---|
| 224 | 1 | | *PANEL; SHUTTER NOISE LH | Missing | 431.00 FL | *431.00 FL |
