Your Ref: TP/IP/36553/2018  
Our Ref : CI/TPD18013726/Z

18<sup>th</sup> October 2018

### **MECHANICAL INSPECTION REPORT OF MOTOR LORRY YN 5405M**

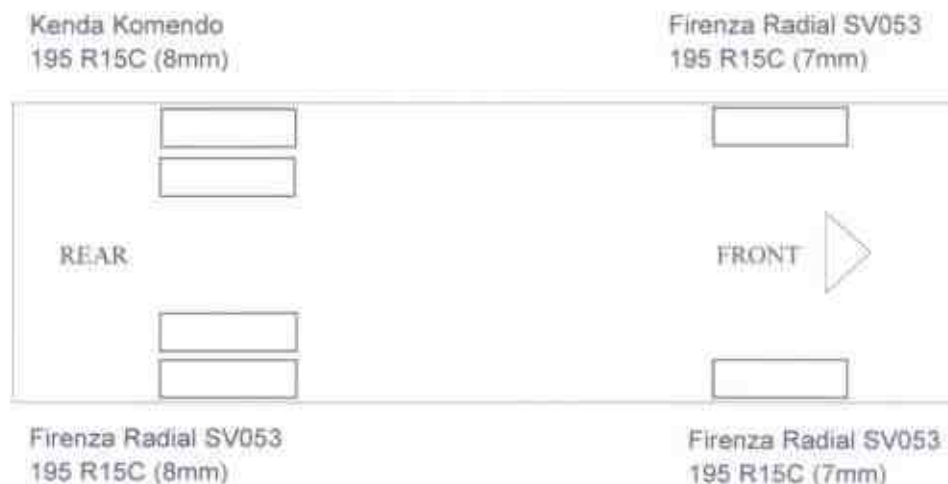
7. The 2 front tyres and 4 rear tyres of the Motor Lorry were observed to be in serviceable condition and sufficiently inflated for vehicular operation. We did not find any tear, cut or burst mark(s) on the outer and the inner sidewalls as well as across the tread of the 6 tyres. The tyre brand, tyre size and remaining tread depth of the 6 tyres were recorded as follows:-
