Your Ref: TP/IP/37553/2018  
Our Ref : CI/TPD18013727/Z

**Fatal Accident Investigation Team**  
Traffic Police Department  
Singapore Police Force  
10 Ubi Avenue 3  
Singapore 408865

### **MECHANICAL INSPECTION REPORT OF MOTORCYCLE FBE 2009M**

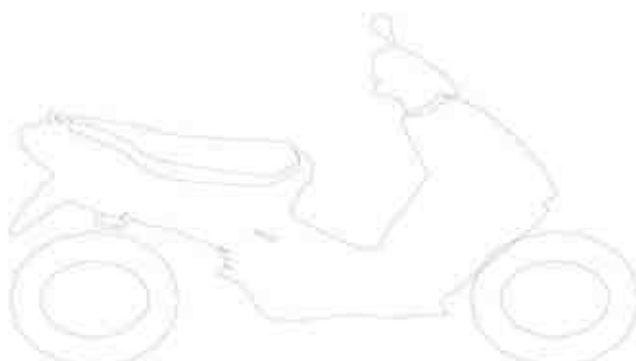
7. The condition of the Motorcycle's 2 tyres was observed to be in serviceable condition. The tread pattern of the 2 tyres was clearly visible. We did not observe any tear, burst mark(s) and/or punctured hole(s) on the sidewalls as well as across the tread of the 2 tyres. The 2 tyres were both observed to be sufficiently inflated for vehicular operation. The tyre brand, tyre size and remaining tread depth of the 2 tyres were recorded as follows:- See photo 9 & 10 below.

Viva R300 60/80 - 17 (5mm)

**Photo 9** shows the front tyre of the Motorcycle at the time of our inspection. The rear tyre was observed to be in serviceable condition with remaining tread depth of approximately 5mm. The tyre was also observed to be sufficiently inflated for vehicular operation. There was no significant damage observed on the rear wheel rim & tyre.
