Your Ref: TP/IP/38117/2018
Our Ref : CI/TPD18013730/Z

10th September 2018

MECHANICAL INSPECTION REPORT OF MOTOR LORRY JRV 1328

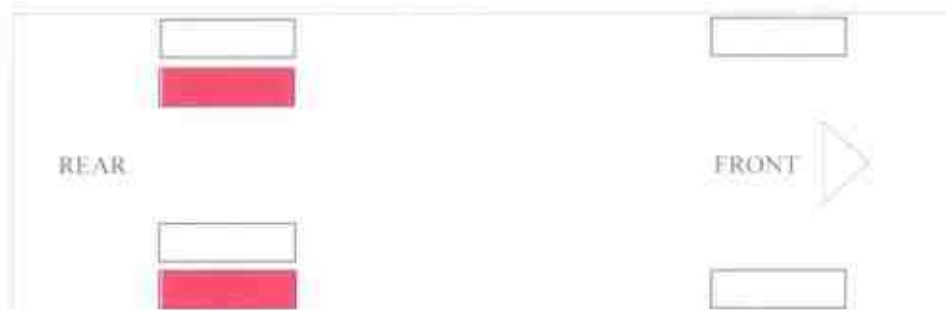
Linglong LFL866 225/80 R17.5 (8mm)
(Deflated)(Cut at outer wall & rim dented)

LEAO AFL866 225/80 R17.5 (4mm) (Deflated)
(Cut at outer wall & rim dented
