Your Ref: TP/IP/38003/2018
Our Ref : CI/TPD18013739/Z

18th September 2018

MECHANICAL INSPECTION REPORT OF MOTORCYCLE JQS 5167

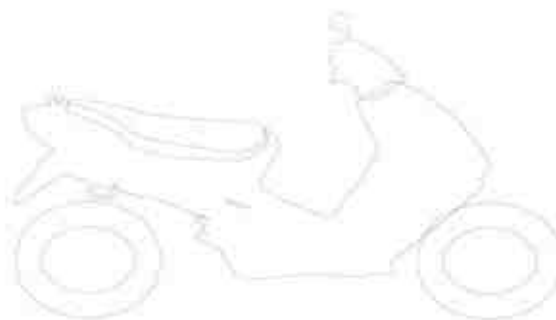
7. The condition of the Motorcycle's 2 tyres was observed to be in serviceable condition. The tread pattern of the 2 tyres was clearly visible. We did not observe any tear, burst mark(s) and/or punctured hole(s) on the sidewalls as well as across the tread of the 2 tyres. The 2 tyres were both observed to be sufficiently inflated for vehicular operation. The tyre brand, tyre size and remaining tread depth of the 2 tyres were recorded as follows:-

Quick GR 629
80/90 - 17 (3mm)

TMax T-Sport
70/90 - 17 (2mm)
