Your Ref: TP/IP/38107/2018
Our Ref : CI/TPD18013740/Z

28th September 2018

MECHANICAL INSPECTION REPORT OF MOTOR TAXI SHC 2164L

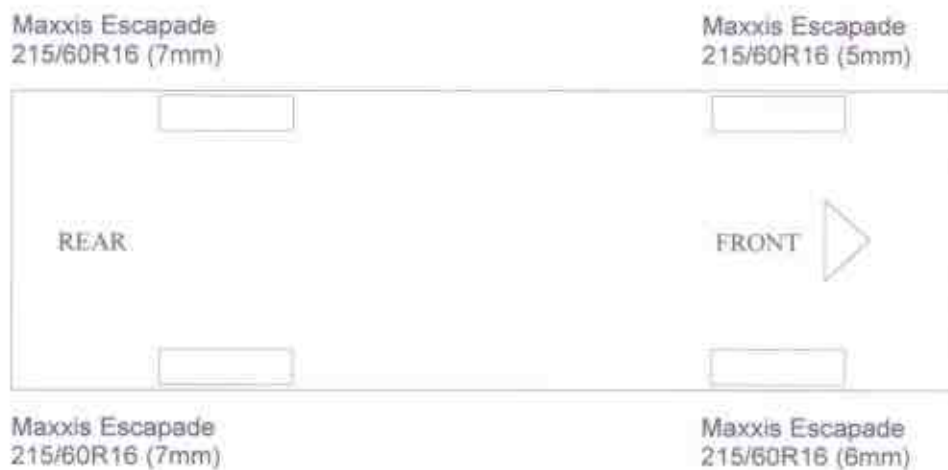
7. The condition of the Motor Taxi's 4 tyres was observed to be in serviceable condition. We did not find any tear, cut or burst mark(s) on the outer and the inner sidewalls as well as across the tread of the 4 tyres. The 4 tyres were also observed to be sufficiently inflated for vehicular operation. The tyre brand, tyre size and remaining tread depth of the 4 tyres were recorded as follows:-
