Your Ref: TP/IP/24523/2018
Our Ref : CI/TPD18013752/Z

MECHANICAL INSPECTION REPORT OF MOTOR CAR SLD 3604A

1. We refer to your request on 10th May 2018 to conduct a physical inspection of a motor taxi bearing registration number SLD 3604A (herein referred to as "**Motor Car**"), which was involved in a fatal road traffic accident on 22nd April 2018.
2. The purpose of this inspection is to primarily determine if there was any possible mechanical failure to the Motor Car that may have contributed to the accident.
3. Following the request, we carried out a physical inspection of the Motor Car on 08th June 2018 at the premises of Traffic Police vehicle pound, 517 Airport Road Singapore 539942. We now set out below our observations and comments with respect to this inspection.

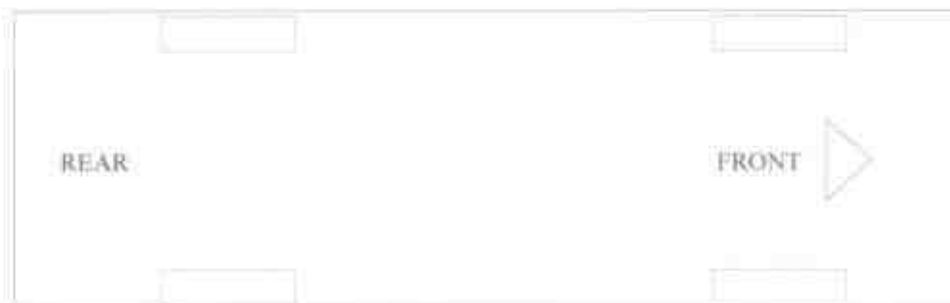
7. The condition of 3 tyres (front left, front right & rear right) of the Motor Car were found to be in serviceable condition. There was no tear, cut or burst mark(s) on the outer and the inner sidewalls as well as across the tread of the 3 tyres. The 3 tyres were sufficiently inflated for vehicular operation with remaining tread depth of approximately 5mm each. As for the rear left tyre, it was observed to be deflated likely due to the accident. A torn mark was found on the outer side wall of the tyre. However, the remaining tread depth was measured to be approximately around 6mm. The tyre brand, tyre size and remaining tread depth of the 4 tyres were recorded as follows:-

Yokohama 225/45R17 (6mm)(Deflated)

Pirelli Contura 225/45R17 (5mm)

Yokohama 225/45R17 (5mm)
