Your Ref: TP/IP/20003/2018
Our Ref : CI/TPD18013753/Z

10th August 2018

MECHANICAL INSPECTION REPORT OF MOTOR CAR SGV 8752L

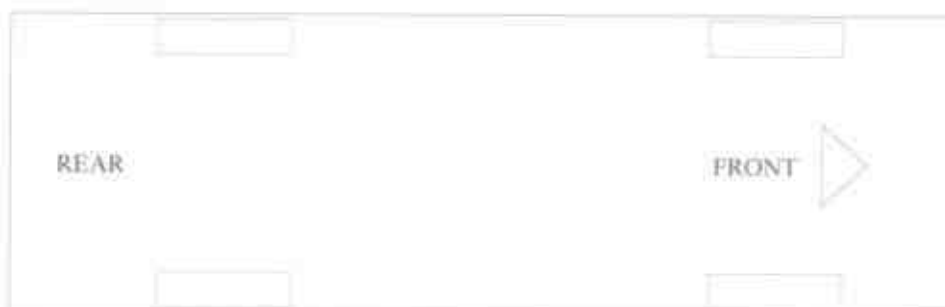
- The condition of the Motor Car's 4 tyres was observed to be in serviceable condition. We did not find any tear, cut or burst mark(s) on the outer and the inner sidewalls as well as across the tread of the 4 tyres. The 4 tyres were also observed to be sufficiently inflated for vehicular operation. The tyre brand, tyre size and remaining tread depth of the 4 tyres were recorded as follows:-

Bridgestone Potenza Adrelin RE003
195/55R15 (6mm)

Bridgestone Potenza Adrelin RE003
195/55R15 (5mm)
