Your Ref: TP/IP/40617/2018
Our Ref : CI/TPD18014209/Z

Fatal Accident Investigation Team
Traffic Police Department
Singapore Police Force
10 Ubi Avenue 3
Singapore 408865

MECHANICAL INSPECTION REPORT OF MOTOR CAR SDV 234D

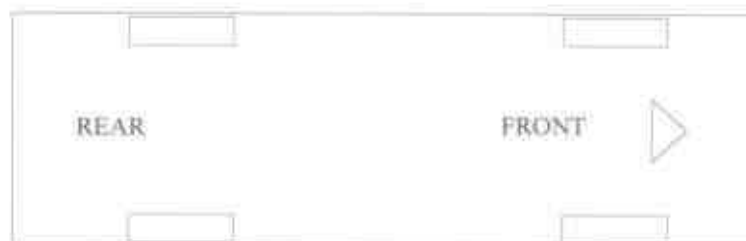
7. The condition of the Motor Car's 4 tyres was observed to be in serviceable condition; we did not find any tear, cut or burst mark(s) on the outer and the inner sidewalls as well as across the tread of the 4 tyres. The 4 tyres were also observed to be sufficiently inflated for vehicular operation. The remaining tread depth of the 4 tyres was approximately between 4mm to 6mm. The tyre brand, tyre size and remaining tread depth of the 4 tyres were recorded as follows:-

Michelin 265/35 ZR19 (4mm)

Good Year 235/35 R19 (6mm)
