Your Ref: TP/IP/41029/2018
Our Ref : CI/TPD18014216/Z

27th September 2018

MECHANICAL INSPECTION REPORT OF MOTORCYCLE FBF 228E

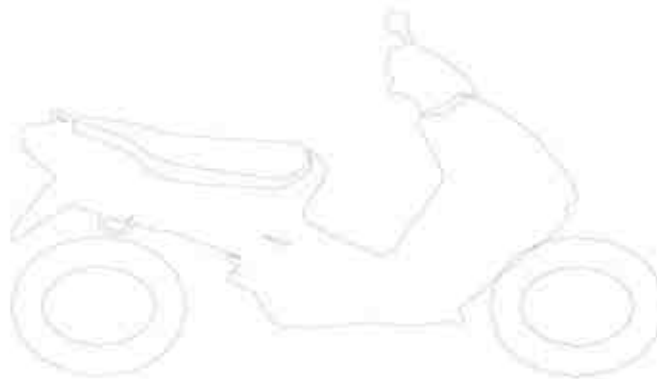
7. The condition of the Motorcycle's 2 tyres was observed to be in serviceable condition. The tread pattern of the 2 tyres was clearly visible. We did not observe any tear, burst mark(s) and/or punctured hole(s) on the sidewalls as well as across the tread of the 2 tyres. The 2 tyres were both observed to be sufficiently inflated for vehicular operation. The tyre brand, tyre size and remaining tread depth of the 2 tyres were recorded as follows:-

Michelin 140/60 - 13 (4mm)

Michelin 120/70 - 14 (4mm)
