Your Ref: TP/IP/39647/2018
Our Ref : CI/TPD18014218/Z

01st November 2018

MECHANICAL INSPECTION REPORT OF MOTOR LORRY GBD 9032D.

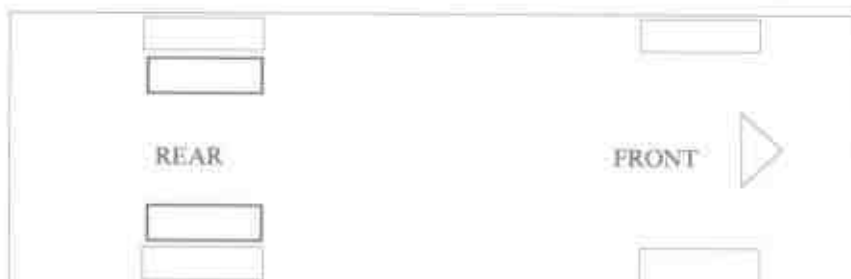
8. The 6 tyres were observed to be in serviceable condition and sufficiently inflated for vehicular operation. We did not find any tear, cut or burst mark(s) on the outer and the inner sidewalls as well as across the tread of the 6 tyres. The tyre brand, tyre size and remaining tread depth of the 6 tyres of the Motor Lorry were recorded as follows:-

Green-Max Van 165 R13C (4mm)

CST Tires.CL-31 195 R15C (5mm)

Westlake Radial SL305 165 R13C (2mm)

Green-Max Van 195 R15C (7mm)
