Your Ref: TP/IP/43847/2018
Our Ref : CI/TPD18016115/Z

28th November 2018

MECHANICAL INSPECTION REPORT OF MOTOR CAR SLM 7686P

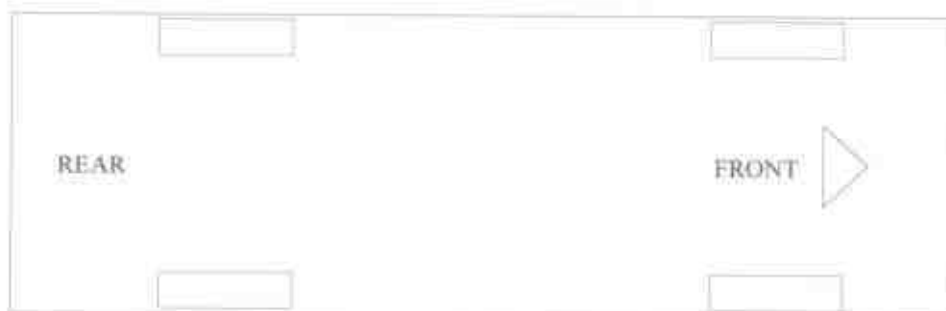
8. The front left tyre was observed to be damaged (deflated & torn) due to the accident's impact. The remaining tread depth of the front left tyre was approximately 5mm.
9. The conditions of the Motor Car's 3 tyres which include front right, rear left & rear right tyres were observed to be in serviceable condition at time of our inspection. We did not find any tear, cut or burst mark(s) on the outer and the inner sidewalls as well as across the tread of the tyre. It was also observed to be sufficiently inflated for vehicular operation. The remaining tread depth of the front right tyre was approximately 6mm & both rear tyres were approximately 5mm each.
10. The tyre brand, tyre size and remaining tread depth of the 4 tyres were recorded as follows:-

Neuton NT 511 195/65R15 (5mm)

Neuton NT 511 195/65R15 (5mm)
(Damaged – Torn & deflated)

Neuton NT 511 195/65R15 (6mm)
