Your Ref : TP/IP/43461/2018  
Our Ref : CI/TPD18016119/Z

**Fatal Accident Investigation Team**  
Traffic Police Department  
Singapore Police Force  
10 Ubi Avenue 3  
Singapore 408865

### **MECHANICAL INSPECTION REPORT OF MOTORCYCLE JQV 5714**

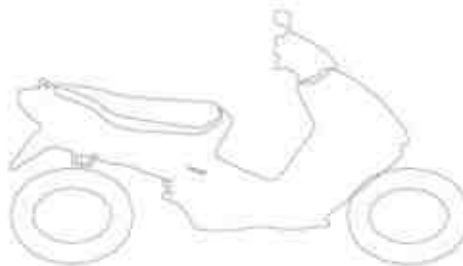
7. The condition of the Motorcycle's rear tyre was observed to be in serviceable condition. The tread pattern of the rear tyre was clearly visible. We did not observe any tear, burst mark(s) and/or punctured hole(s) on the sidewalls as well as across the tread of the rear tyre. The tyre brand, tyre size and remaining tread depth of the 2 tyres were recorded as follows:-

Maxxis 80/90 – 17(3mm)

Maxxis 70/90 – 17(3mm)
