Your Ref: TP/IP/47547/2018  
Our Ref :CI/TPD18016123/Z

**Fatal Accident Investigation Team**

**MECHANICAL INSPECTION REPORT OF MOTORCYCLE FBE 785T**

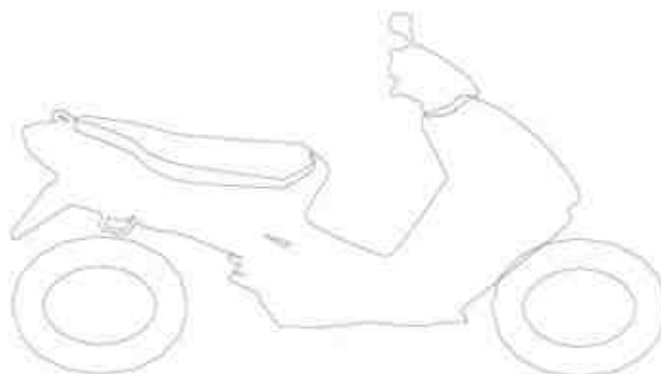
7. The condition of the Motorcycle's 2 tyres was observed to be in serviceable condition. The tread pattern of the 2 tyres was clearly visible. We did not observe any tear, burst mark(s) and/or punctured hole(s) on the sidewalls as well as across the tread of the 2 tyres. The 2 tyres were both observed to be sufficiently inflated for vehicular operation. The tyre brand, tyre size and remaining tread depth of the 2 tyres were recorded as follows:-

Metzeler Sport EL Street  
110/70 - 17 (5mm)

Metzeler Sport EL Street  
90/80 - 17 (5mm)
