**SURVEY OF VEHICLE NO. SJT 4592H** ✓

**THIRD PARTY SURVEY**  
**ACCIDENT HAPPENED ON 4 Oct 2017**

**EVALUATION REPORT (PAPER SURVEY) OF ACCIDENT VEHICLE NO:  
SJT 4592H INSURED VEHICLE: YP 5879T ACCIDENT DATE: 04/10/2017**

## ADJUSTMENT ON REPAIR COST FOR VEHICLE NO. SJT 4592H

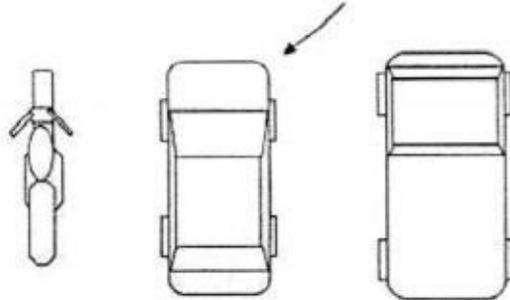
At the time of inspection, this vehicle sustained damages to the **O/S Front** portion. Please see attached scheduled for details.
