Your Ref: TP/IP/48921/2018
Our Ref : CI/TPD18016725/Z

10th January 2019

MECHANICAL INSPECTION REPORT OF MOTOR BUS PC 3156J

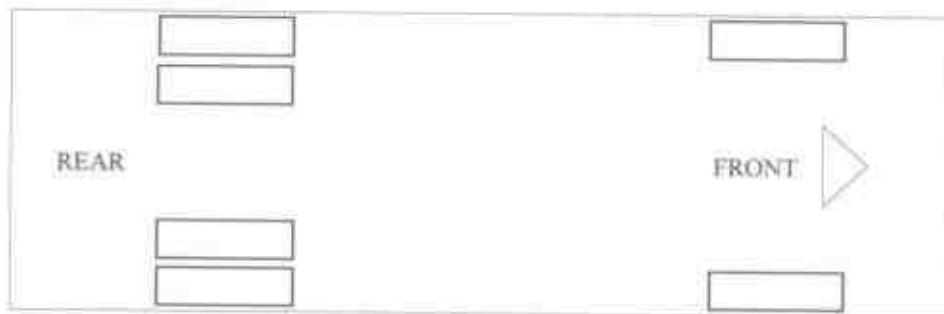
7. The 6 tyres fitted on the Motor Bus were all observed to be in serviceable condition and sufficiently inflated for vehicular operation. We did not find any tear, cut or burst mark(s) on the outer and the inner sidewalls as well as across the tread of the 6 tyres. The tyre brand, tyre size and remaining tread depth of the Motor Bus's 6 tyres were recorded as follows:-

Falken RI-128 295/80 R22.5 (7mm)

Bridgestone R150 II 295/80 R22.5 (8mm)

Falken RI-128 295/80 R22.5 (5mm)
