Your Ref: TP/IP/48837/2018
Our Ref : CI/TPD18016726/Z

09th January 2019

Fatal Accident Investigation Team

MECHANICAL INSPECTION REPORT OF TIPPER TRUCK XE 694L

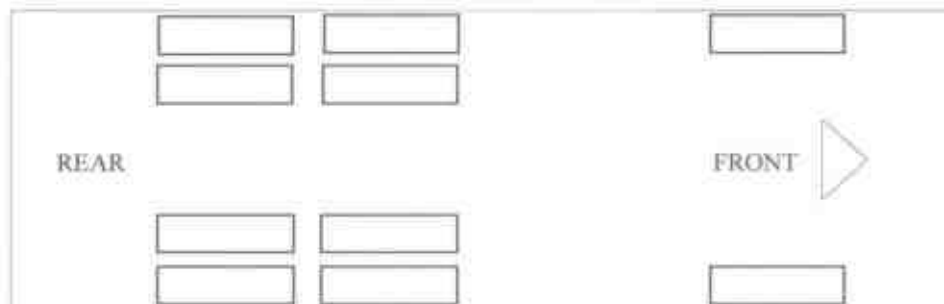
7. The 2 front tyres and 8 rear tyres of the Tipper Truck were observed to be in serviceable condition and sufficiently inflated for vehicular operation. We did not find any tear, cut or burst mark(s) on the outer and the inner sidewalls as well as across the tread of the 10 tyres. The tyre brand, tyre size and remaining tread depth of the 10 tyres of the Tipper Truck were recorded as follows:-

Aeolus ADC 53
295/80 R22.5 (4mm)

Double Coin
295/80 R22.5 (4mm)

Firenza SML68A
295/80 R22.5 (9mm)

Firenza SSR 05A
295/80 R22.5 (4mm)
