Your Ref: Honda Engine  
Our Ref : CI/TP18017008/D

18 September 2018

**INSPECTION REPORT OF A HONDA ENGINE WITH ENGINE NUMBER  
K20A5841950**

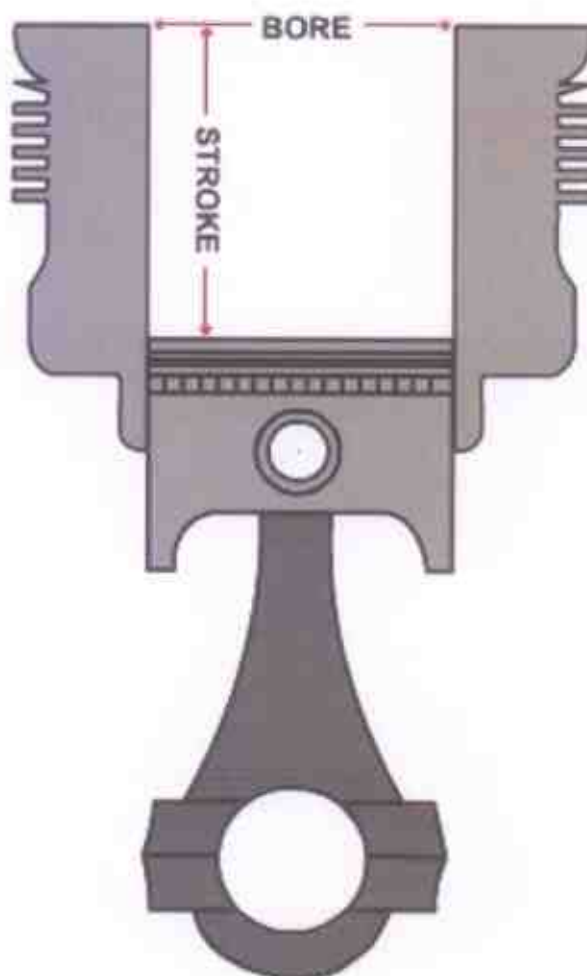
9. The bore refers to the measurement of the inside diameter of the cylinder while the stroke refers to the distance the piston moves in one direction of upward or downward movement in the cylinder. See diagram below for illustration purposes.
