24 September 2018

Your Ref: Honda Engine

Our Ref : CI/TP18017321/D

#### INSPECTION REPORT OF A HONDA ENGINE WITH NUMBER B16A1014205

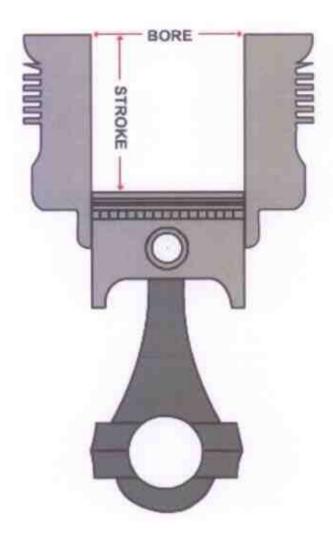
The bore of an engine refers to the measurement of the inside diameter of the cylinder while the stroke refers to the distance the piston moves in one direction of upward or downward movement in the cylinder. See diagram below for illustration purposes.
