N3/INC18018146 / KHLbn2

### 1. Policy Particulars :- THIRD PARTY CLAIM

### 4. Description of Damages

## ADJUSTMENT ON REPAIR COST FOR VEHICLE NO. SHA 1600L

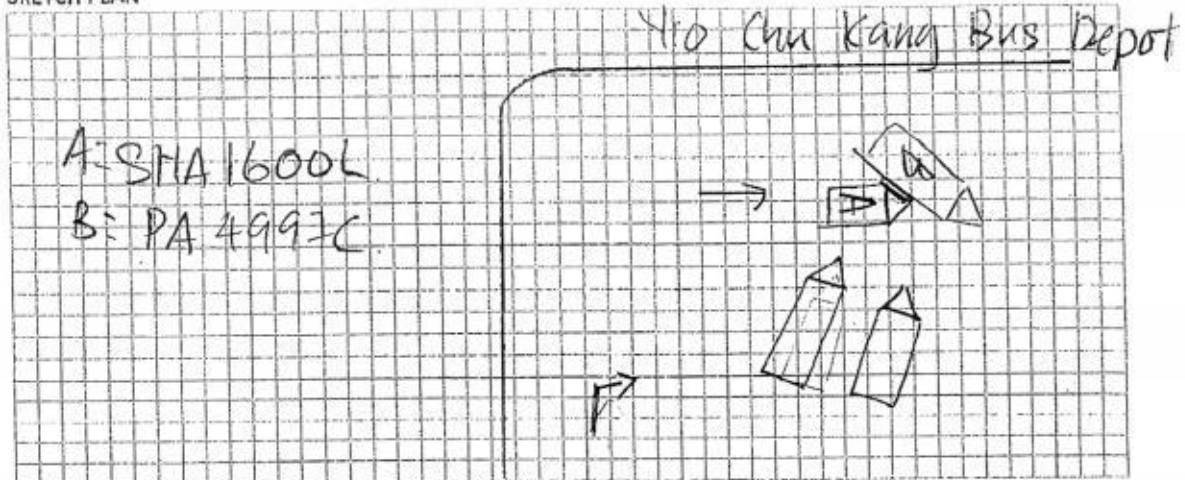
SKETCH PLAN

On 3/10/18 at about 14:30 hrs, I was driving in Yio Chu Kang Bus depot at AMK St 63. At the point time, I was travelling beside of Veh B. Suddenly Veh B swerved right into my path, I immediately applied brake upon seeing this and honked to alert the bus driver. However, Veh B still ongoing and it right rear portion hit onto front left portion of my stationary taxi. No passenger in both vehicle. No injury reported.

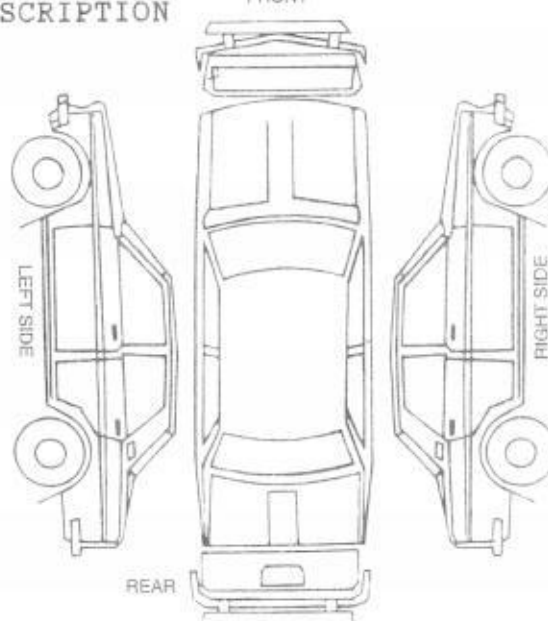
THE VEHICLE SUSTAINED DAMAGES AT THE FRONT N/S PORTION. DAMAGES SEE DETAILS.
---
