Your Ref: TP/IP/53769/2018
Our Ref :CI/TPD18018437/Z

19th November 2018

MECHANICAL INSPECTION REPORT OF MOTORCYCLE JSH 9356

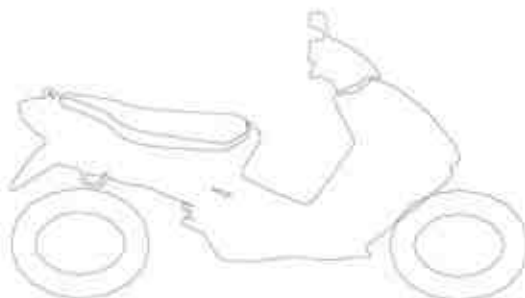
7. The condition of the Motorcycle's front & rear tyres were observed to be in serviceable condition. The tread patterns of both tyres were clearly visible. We did not observe any tear, burst mark(s) and/or punctured hole(s) on the sidewalls as well as across the tread of both tyres. The tyre brand, tyre size and remaining tread depth of the 2 tyres were recorded as follows:-

Maxxis 90/80 – 17(5mm)

Maxxis 70/90 – 17(4mm)
